Shorezone Functionality

Ohrid Lake

Implementing the EU Water Framework Directive in South-Eastern Europe

Conservation and Sustainable Use of Biodiversity at Lakes Prespa, Ohrid and Shkodra/Skadar (CSBL)

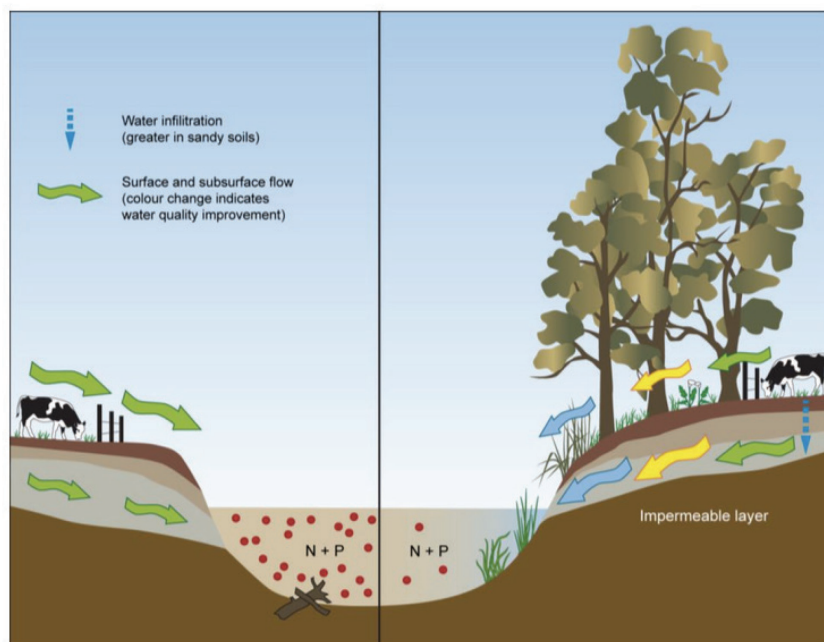
The lake's riparian vegetation plays an important role as a buffer that helps to protect the aquatic ecosystem against degradation caused by human activities (Dosskey et al. 2010). Studies by Osborne and Kovacic (1993) have shown that the riparian zone can efficiently intercept nutrients emanating from nearby agricultural areas, diminishing by over 90% the nitrogen and phosphorus content of both the superficial and sub-superficial waters flowing into the water body (Figure 1).

Figure 1. Nutrient interception by riparian vegetation (Dosskey et al. 2010)

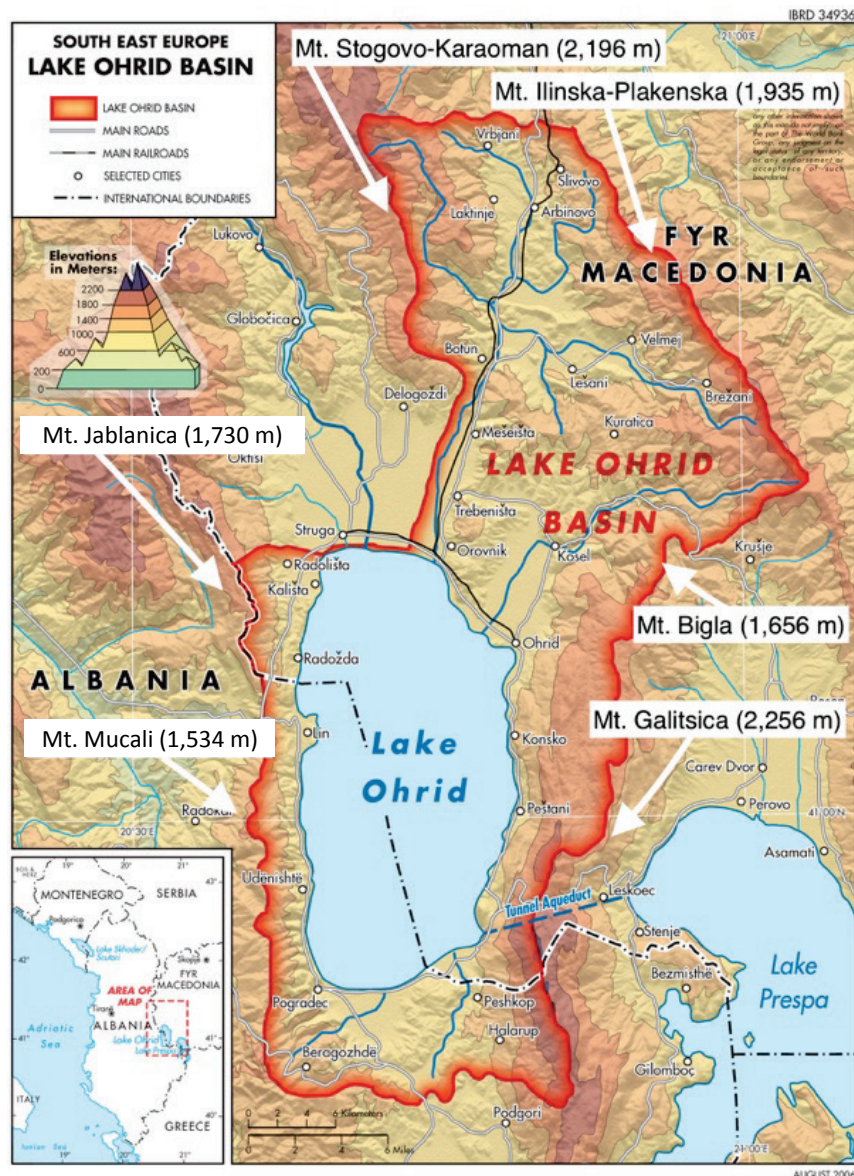
Figure 11. Topography of the Ohrid Lake drainage basin and its main peaks

Three quarters of the perimeter of the Ohrid Lake drainage basin comprises ridges of high mountains. The remaining quarter on the northern side of the basin is open and contains the outlet that constitutes the source of the Drin River (Figure 11).

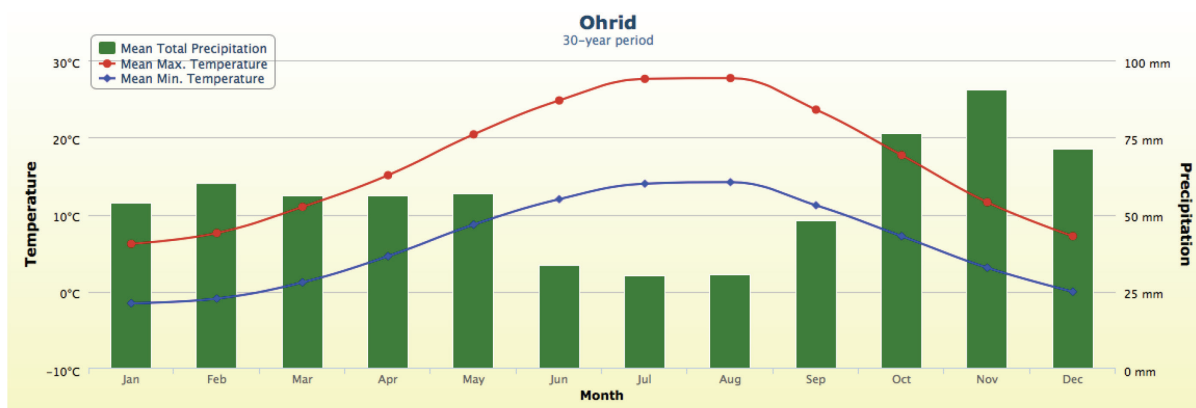
Data on precipitation, cloud cover, humidity and temperature are collected daily at the main meteorological stations in Ohrid (positioned 760 m above sea level, HGM area III) (Figure 12).

Figure 12. Meteorological parameters for the Ohrid station

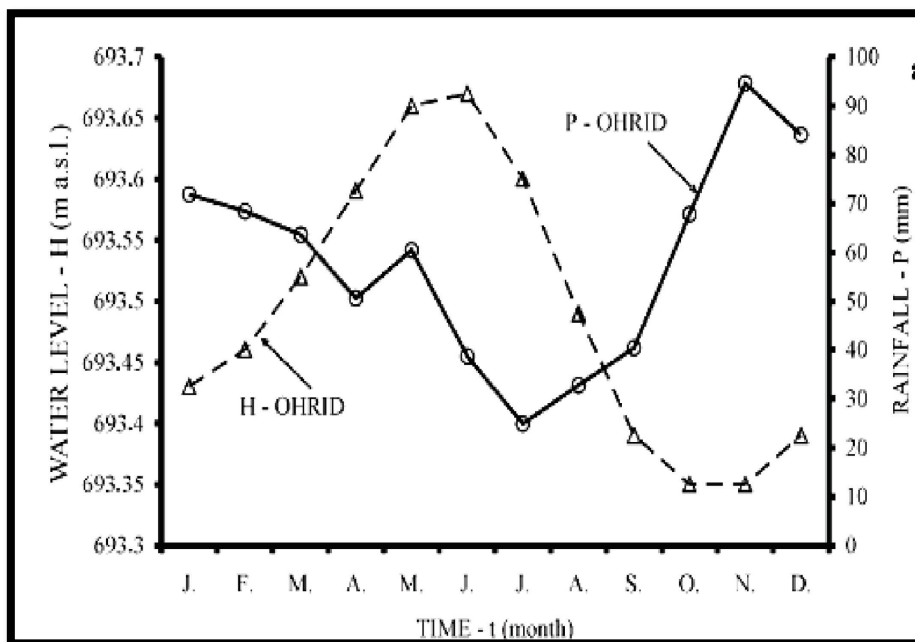
Lake water-level oscillation and precipitation reach maximum and minimum levels in different seasons. Maximum precipitation occurs in the form of snowfall in November, when the lake’s water levels are at their lowest. The snow remains throughout the winter at altitudes above 1,000–1,500 m a.s.l. but begins melting in April. The meltwater enters the lake, which then reaches its maximum water level in June (Popovska and Bonacci2007) (Figure 17).

Figure 17. Overview of average monthly water-level variations (dotted line) and average monthly rainfall (solid line) for the period 1961–90 observed on Ohrid Lake (at the Ohrid gauging station and at Ohrid meteorological station) (Popovska and Bonacci 2007)

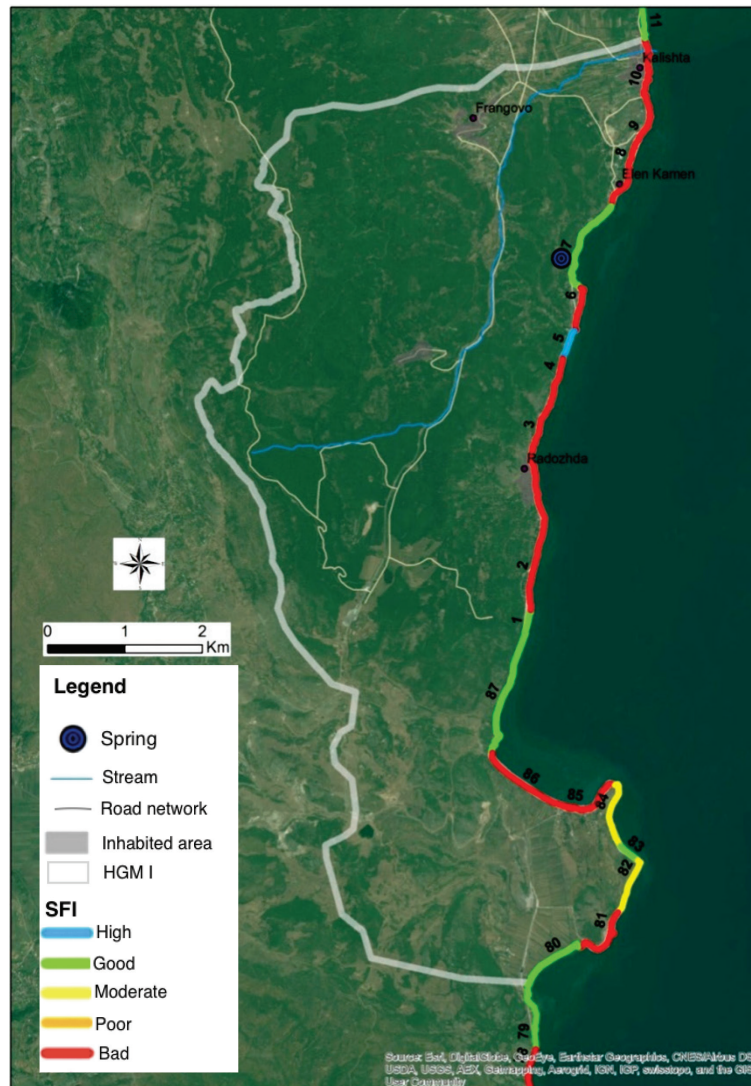
Figure 25. Map of HGM area I

HGM area I (Figure 25) is located in the most north-westerly part of the lake. It starts in Albania, includes Lin peninsula, and runs northwards up to the Macedonian town of Kališta. The area is characterised by the presence of the Jablanica mountain range, which is mainly composed of permeable limestone (Mount Jablanica reaches 1,730 metres above sea level). HGM area I contains 16.1 km of shoreline and covers an area of 40.7 km², most of which is covered by natural forest.

Hills descend here almost directly into the lake, leaving little scope for the development of riparian vegetation close to the shoreline. The surrounding territory is naturally covered with low-growing oak forest on the Macedonian side, while on the Albanian side this has been replaced by agricultural fields and grazing areas and only ash and hornbeam trees have been recorded.

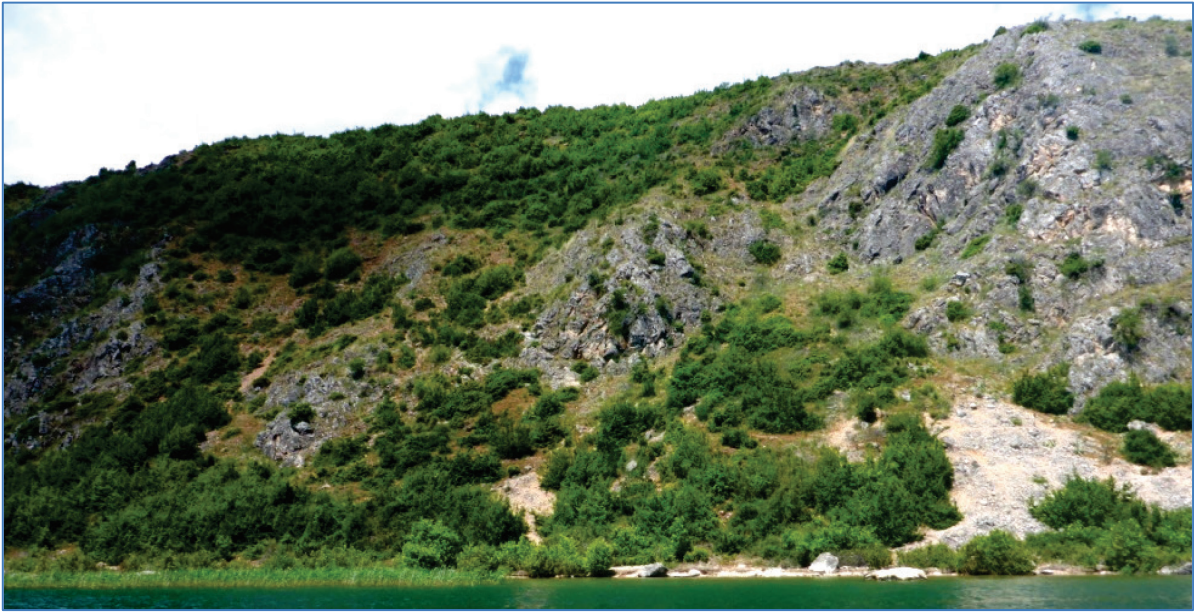
Figure 26. Example of a typology 3 shorezone (cliff with limited vegetation)

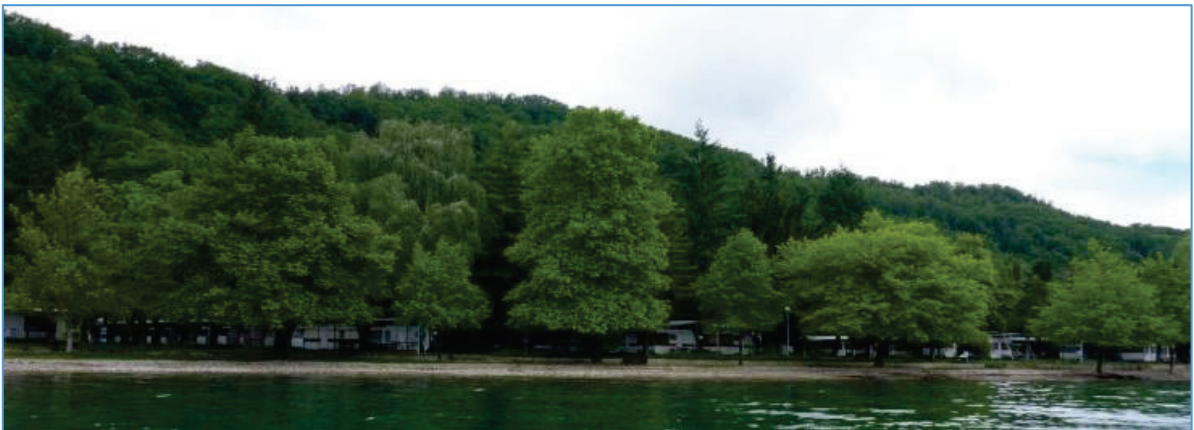
In its natural state, the Macedonian shorezone would offer a high or good level of functionality. However, almost the entire Macedonian shorezone is inhabited, so the prevailing shore typology identified is 6 (artificial shores; see Figure 27).

Figure 27. Example of a typology 6 shorezone

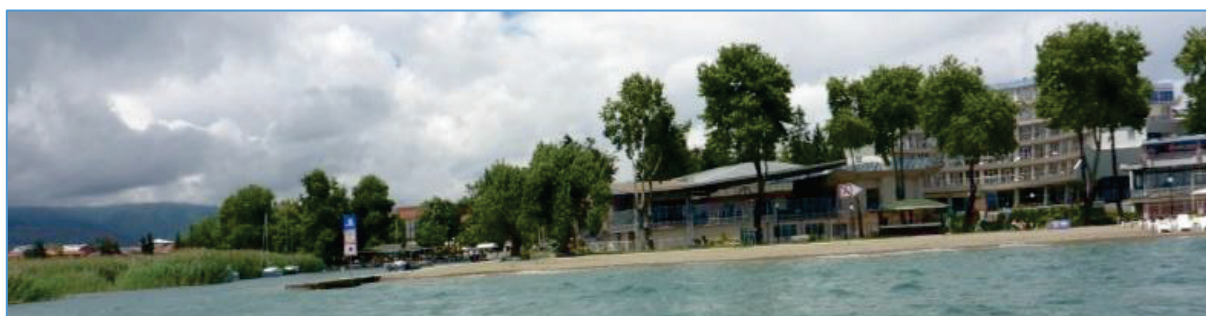
Figure 28b. Example of shore that displays a high level of human impact

The surrounding territory is flat, comprising lake/alluvial sediments, and is experiencing substantial anthropogenic pressure. Intensive farming is practiced on HGM area II's western side, while the eastern side comprises the urban area of Struga town. In general, the shoreline comprises sustaining walls and tourist beaches (typology 5; see Figure 28b) and has therefore lost its functionality. Although terrestrial riparian vegetation is not established on the western corner of the lake, the presence of reeds in the littoral zone constitutes a small area of remaining functional habitat for aquatic species.

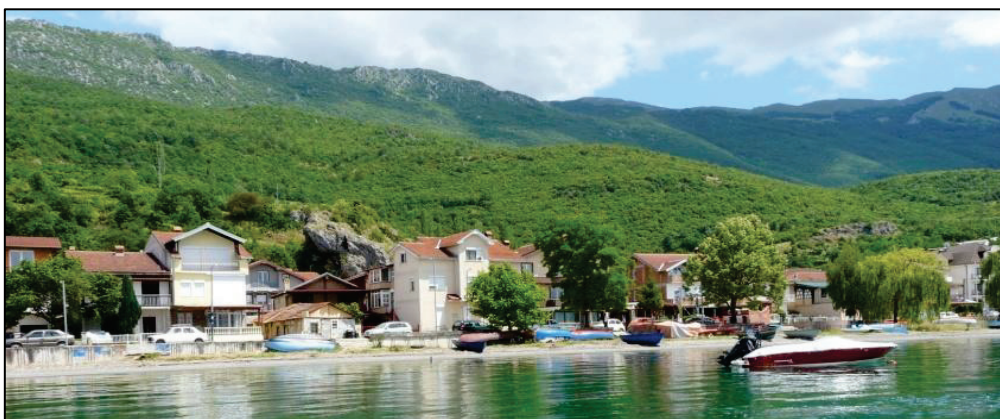
Figure 31. Example of the predominant shorezone typology 6

The surrounding territory is used for non-intensive farming and becomes increasingly natural as one move towards the southern end of the lake. Human settlements are concentrated closer to the shore, and a number of villages and tourism facilities are located directly along the shoreline. Because of the high level of human pressure in the shorezone, it is mainly classified as typology 6 (artificial shorezone; see Figure 31).

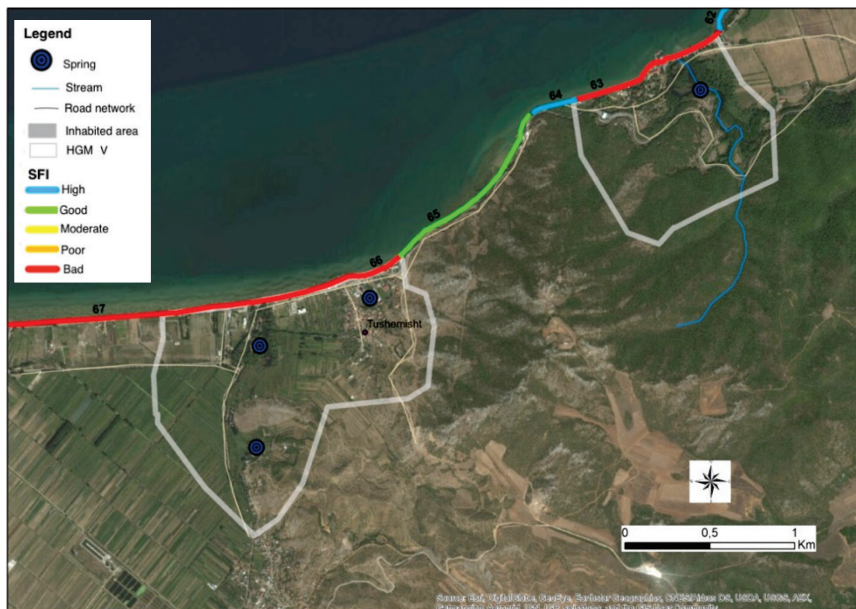
Figure 33. Map of HGM area V

HGM area V (Figure 33) consists of a small promontory formed of the same calcareous rock found in HGM area IV, which marks a natural border between Macedonia and Albania. It is separated from the Galitsica mountain range by the Çerava River (HGM area VI).

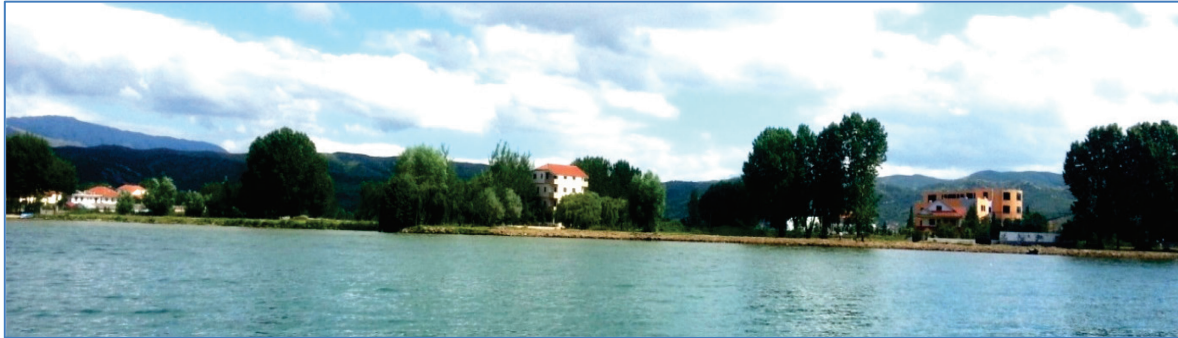
Figure 35. Example of the typology 6 shorezone, which is predominant in this area

Most of the 8.7 kilometres of shoreline in HGM area VI are under strong anthropogenic pressure (typology 6; see Figure 35) and now contain numerous artificial beaches and tourist resorts. These shores cannot perform any ecological functions and are therefore not able to filter out the nutrient load that washes into the lake here from the surrounding farmland.

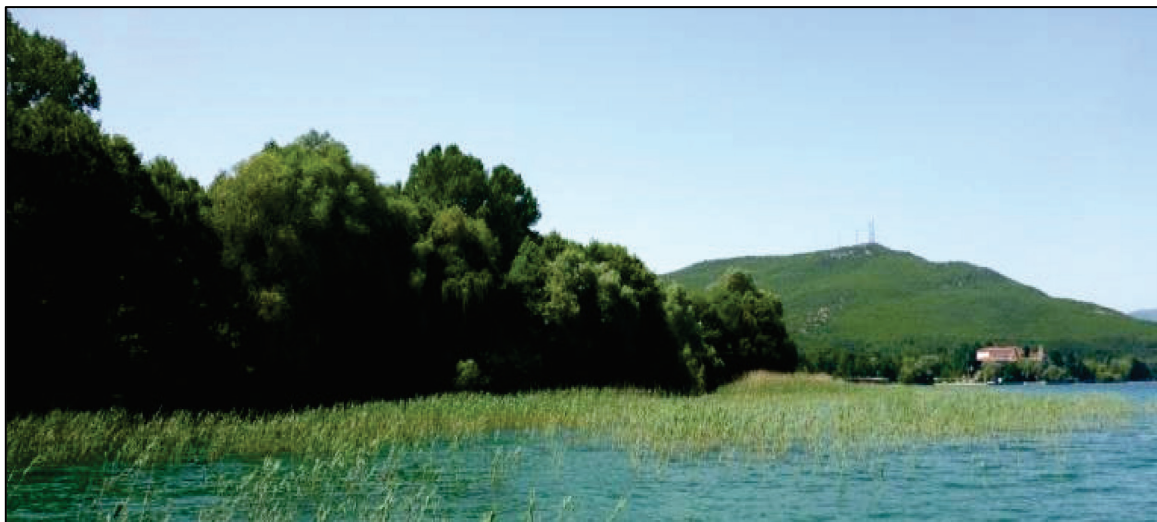
Figure 36. Example of typology 1 shorezone

It is only in the area close to the mouth of the Çerava River that the shorezone regains its naturalness, with shorezone functionality here ranging from moderate to high (Figure 36).

Typology 1 is characterised by a belt of riparian vegetation (shrub and trees) accompanied by reeds in the littoral zone, and it provides a high value of complexity and functionality (SFI = 1) (Figure 39). As the Albanian side of the lake has experienced particularly high levels of anthropogenic pressure, this typology is found only on the Macedonian side, scattered along the shoreline in a few pockets that remain in pristine condition. Typology 1 shorezone falls into the high category for functionality.

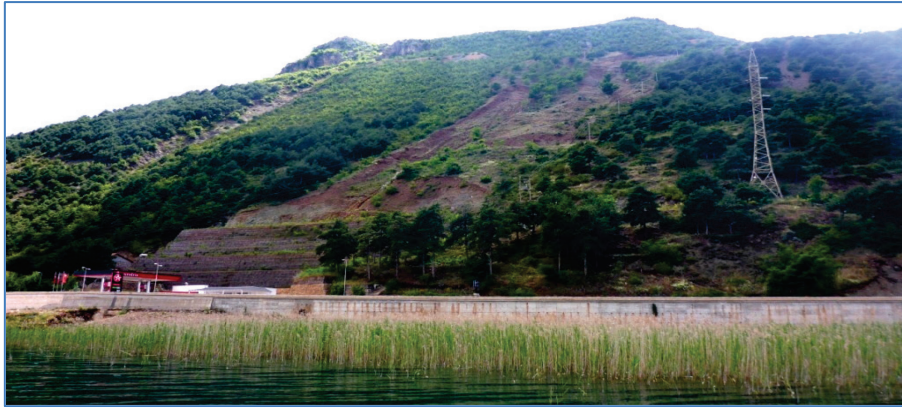
Figure 38. Example of a typology 7 shorezone, which is predominant in this area

is covered with small trees or shrubs. A main road runs close to the shore for most of the shoreline and is often supported by sustaining concrete walls that run right along the shoreline (Figure 38). Illegal buildings previously built right on the shoreline have recently been demolished, but the remnants of these constructions are still visible in several stretches. The functionality of this area is bad (category 5), as it is not able to provide any ecological functions.

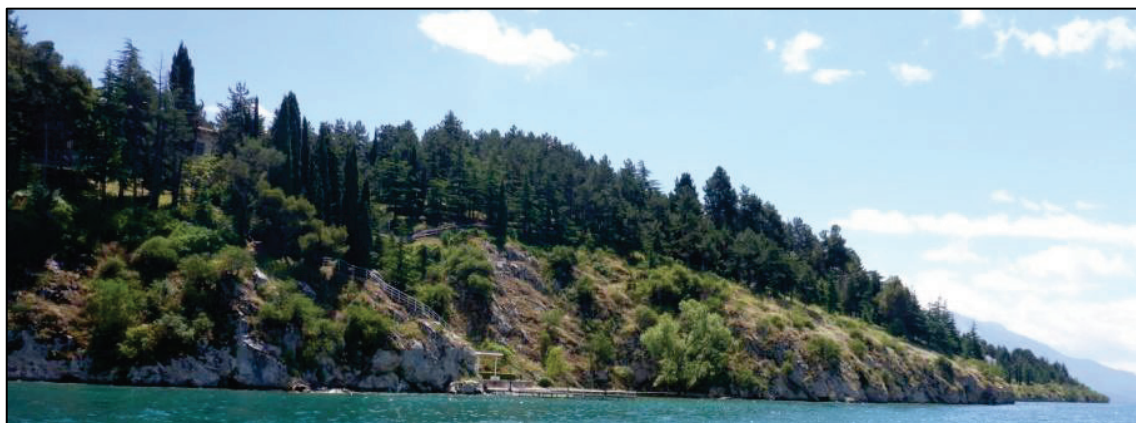
Typology 3 is characterised by cliffs that directly abut the lake. Even where the cliffs are not high, they constitute an obstacle for the development of coastal hygrophilous vegetation and, as a result, the shorezone mainly comprises bare rock and scattered shrubs (Figure 41). This is another example of a natural place that has limited functionality (average functionality: SFI = 3). This typology occurs in HGM areas I and IV.

Figure 41. Rocky shores with sparse vegetation – natural but not functional

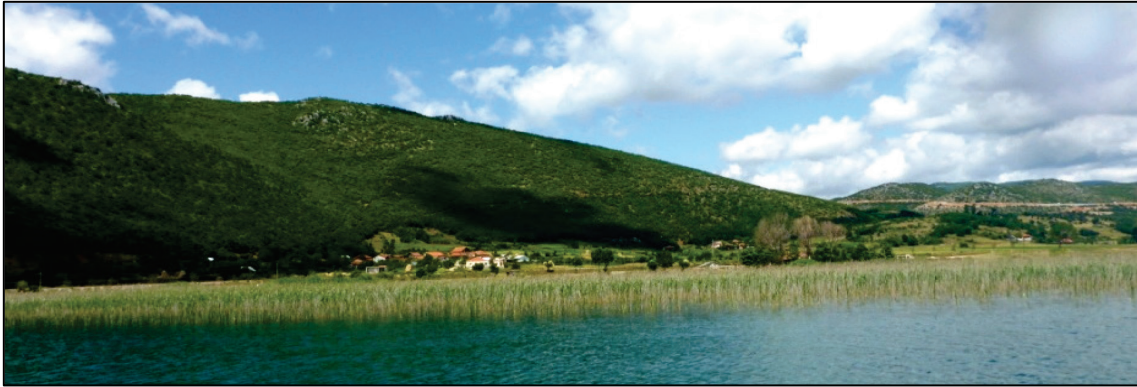
The terrestrial environment of the lakeside plains has been intensively farmed, with the natural riparian vegetation removed and replaced with crops. In the water, however, the shallower bathymetry in this area promotes the growth of reeds, which can grow in wide belts hundreds of metres wide (Figure 42). These wide reed belts perform a number of ecological functions: they provide habitat for aquatic fauna and they remove some of the nutrient load that runs off the land into the lake. These shorezones are therefore considered to have good or moderate functionality (SFI = category 2 or 3).

Figure 42. Reeds, with little or no terrestrial riparian vegetation

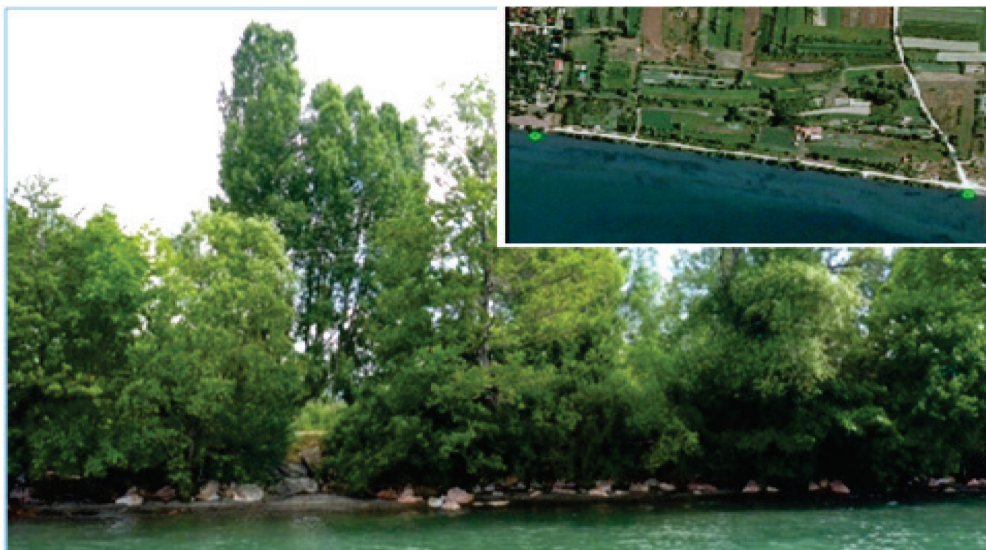
In typology 5, the belt of riparian trees and/or shrubs is, similar to typology 2 but more limited in width (Figure 43). However, in this case human pressure is the main factor limiting the growth of riparian vegetation. At Ohrid Lake, for example, a tarmac road runs a few metres parallel to the shoreline, which not only interrupts the shorezone but also constitutes a moderate pollution risk for the lake. The shorezone functionality for this typology is moderate (SFI = 3).

Figure 43. Thin belt of riparian trees, high artificiality

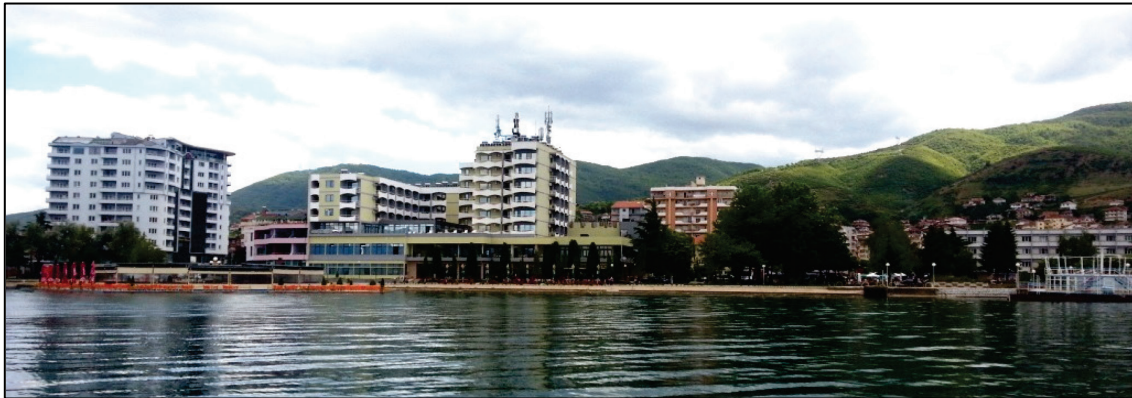
The shorezone of Ohrid Lake has been heavily modified to accommodate tourism (Figure 44). Artificial beaches line sections of the shore and impermeable retaining mortar-bonded walls often abut directly on the shoreline to enable the construction of tourism infrastructure. Retaining walls have also been built along the shore to facilitate the construction of the road that encircles the lake. Some ornamental trees have been planted for aesthetic reasons but, unfortunately, they are often exotic rather than autochthonous riparian species. Therefore, they fail to improve the already poor functionality of these areas. For this reason, the shorezone functionality for this typology, which is present in all parts of the lake, is bad (SFI = 5).

Figure 44. Shoreline with strong anthropogenic disturbance

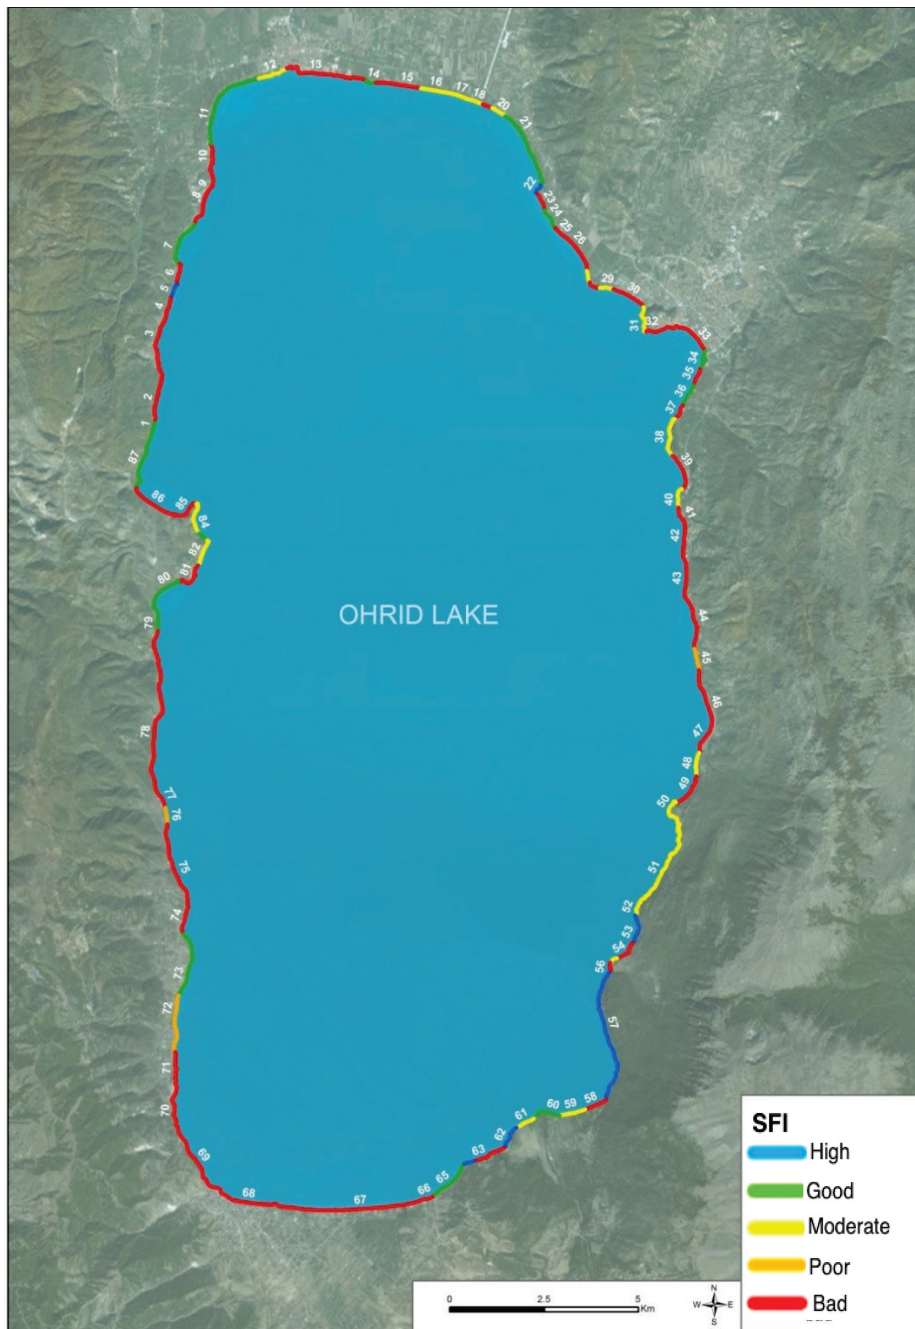
Figure 46. Shorezone Functionality Index for Ohrid Lake

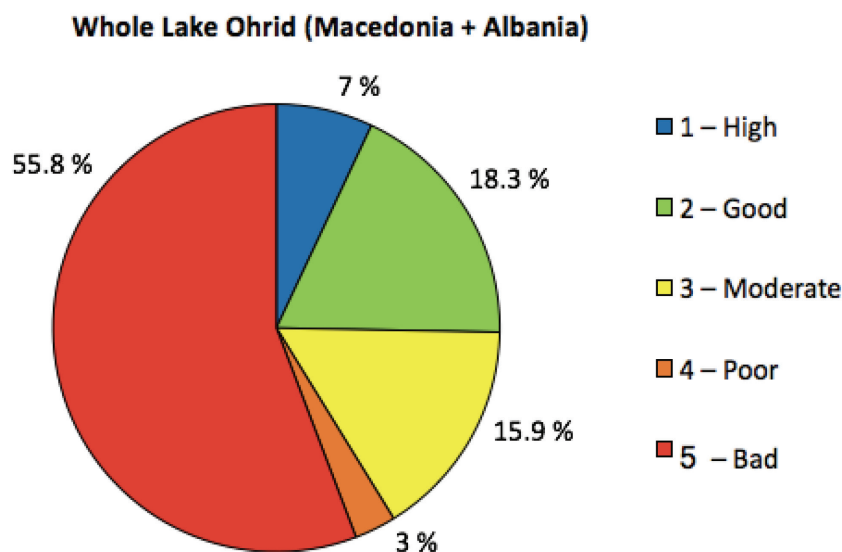
Figure 48. Ohrid Lake's SFI value percentages (Macedonian and Albanian territories combined)

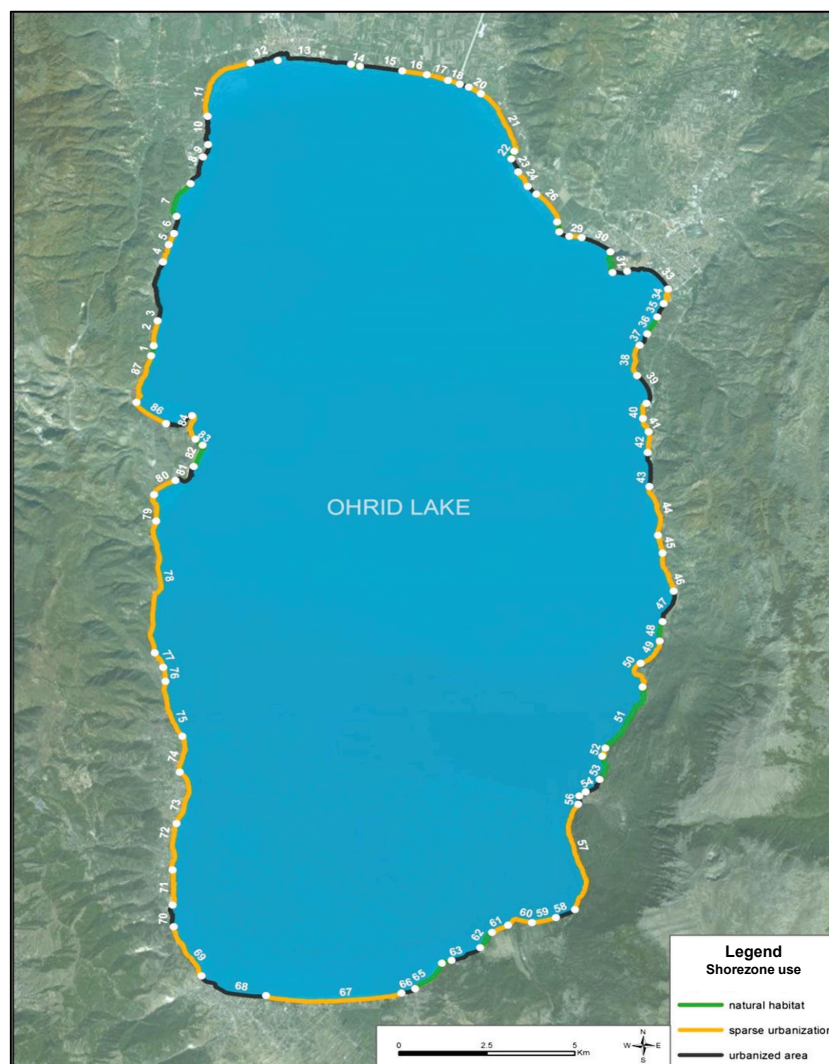
Figure 49. Human use of the lake's shorezone (0 to 50 metres from the shoreline)

Information on the types of human use of the lake's shorezone (i.e. the circumferential strip from the shoreline to 50 metres inland) and the surrounding territory (the circumferential strip from the shoreline to 200 metres inland) was also collected during the survey (Figure 49).

The urbanized areas that directly affect the lake's shorezone (0 to 50 metres inland from the shoreline) are the basin's main urban centres of Struga, Ohrid and Pogradec, and also smaller villages with tourist beaches (dark grey, 29.6% of the lake's whole perimeter).

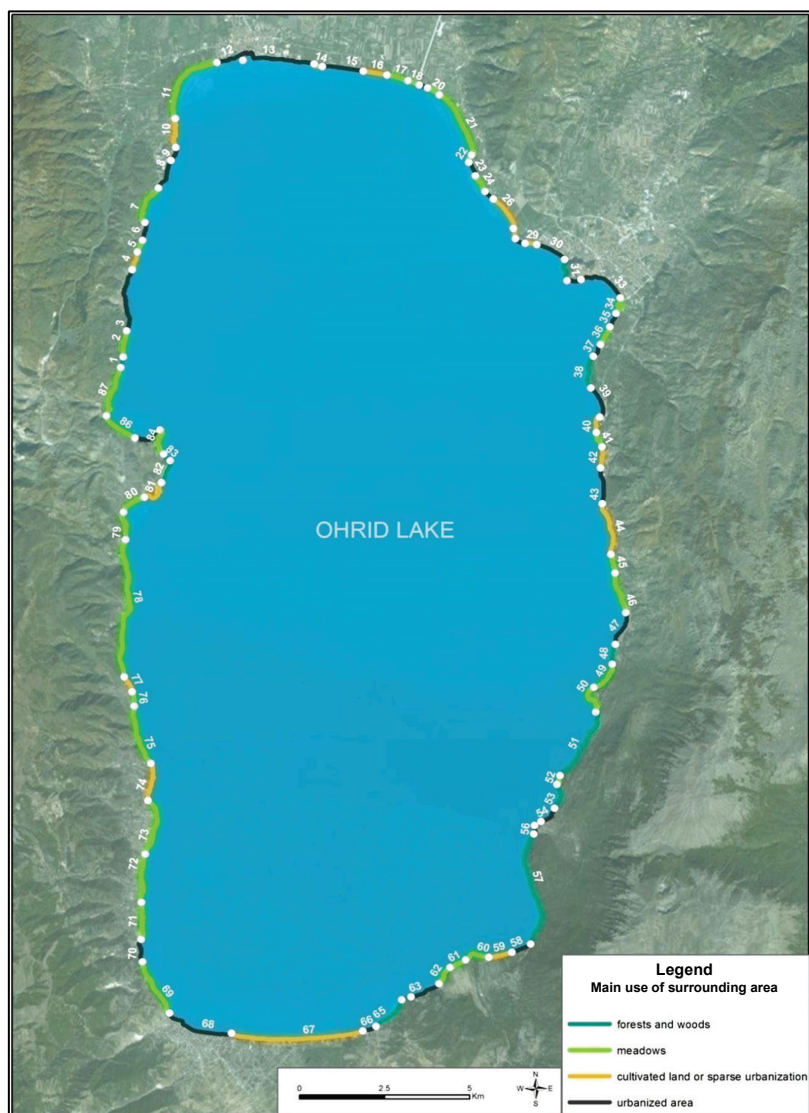
Figure 50. Human use of the surrounding area (0–200 metres inland from the shoreline)

Figure 50 depicts prevalent human activities in an area running from the shoreline to 200 metres inland. The map indicates impairments to the shorezone’s functionality occurring as a result of the modification of the surrounding soil that may increase the input of nutrients, organic matter or pollutants and change the natural permeability of the soil. The predominant human use present in each identified homogeneous stretch is adopted as the use for that stretch (Figure 50).

The forest and woods category (dark green) occurs only in the part of the lake that falls within the confines of Galitsica National Park, which is located in the south-eastern corner of the lake (HGM area IV).

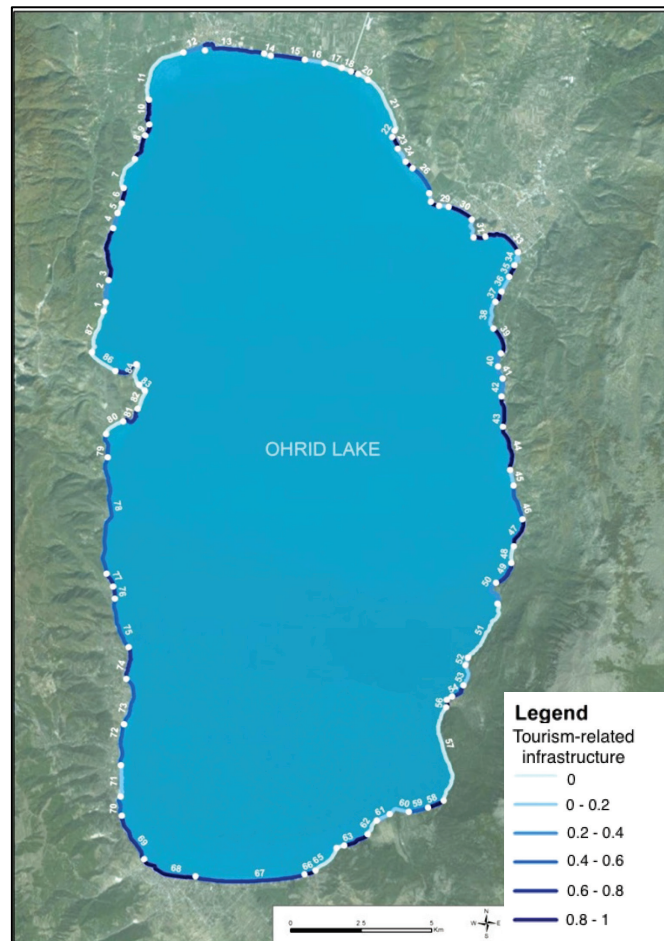
Figure 51. Tourism-related infrastructure (Range: 0 = none to 1 = 100% along entire stretch) (0.1 = hiking trail; 0.2 = single hotel; 0.5 = pedestrian/cycle path alongside lake; 1 = beach or tourism infrastructure)
