Shorezone Functionality

Prespa Lake

Implementing the EU Water Framework Directive in South-Eastern Europe

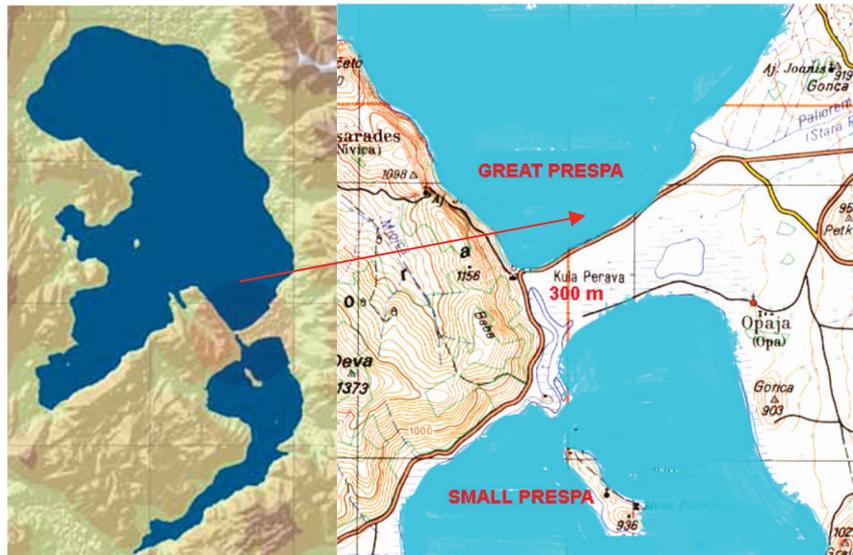
Figure 10. Macro and Micro Prespa lakes and the isthmus between them

Prespa Lake is a high-altitude lake system sitting approximately 850 metres above sea level (a.s.l.). The lake system consists of two interlinked lakes – Macro Prespa and Micro Prespa – that are separated by an isthmus. Between 1962 and 1975, water levels of both lakes were similar owing to a canal connecting the lakes at the outflow of Micro Prespa (Figure 10) (PLWMP-TR1 2010).

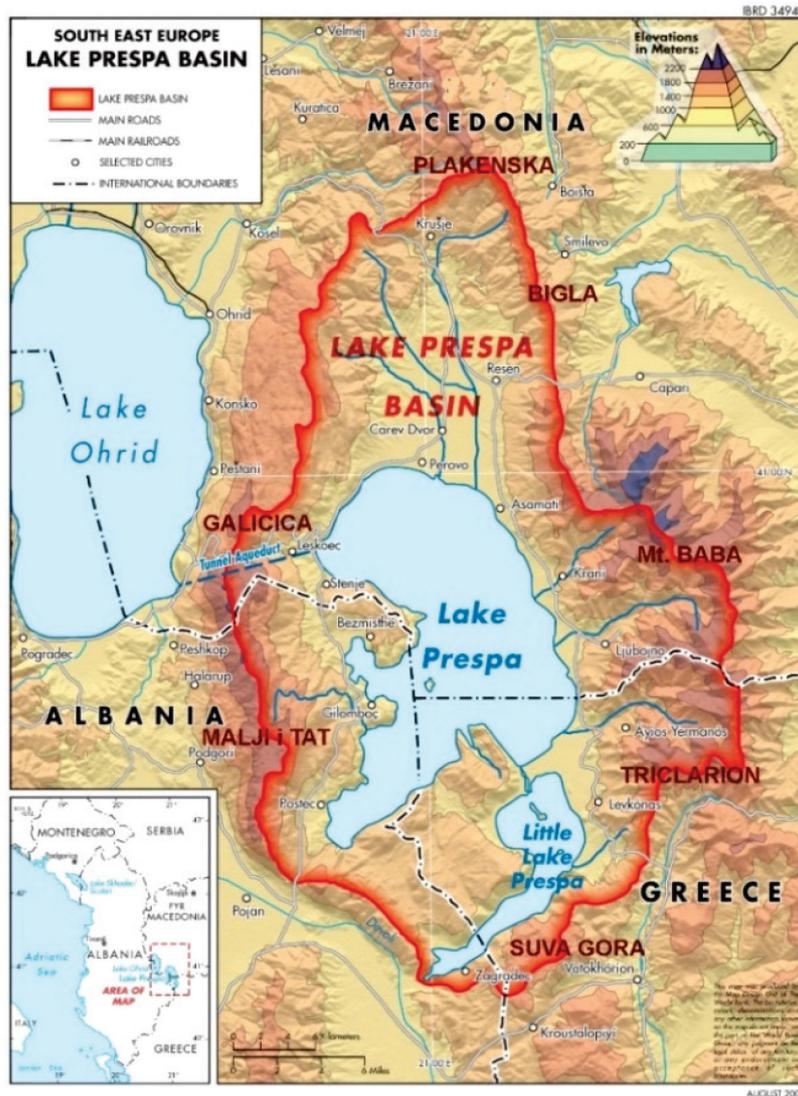
Figure 13. Prespa Lake (Micro and Macro) drainage basin showing the ring of mountains enclosing it (World Bank 2006)

Conversely, on the northern side there is a large basin (Figure 13) that separates the lake from the surrounding mountains (Mount Plakenska at 1,935 m).

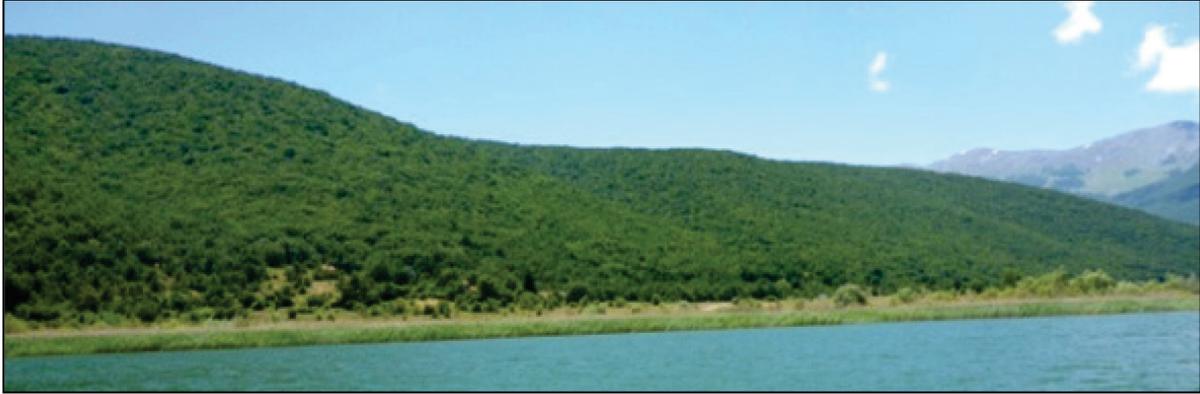
Figure 24. Example of a typology 3 shorezone: cliff skirted by reeds

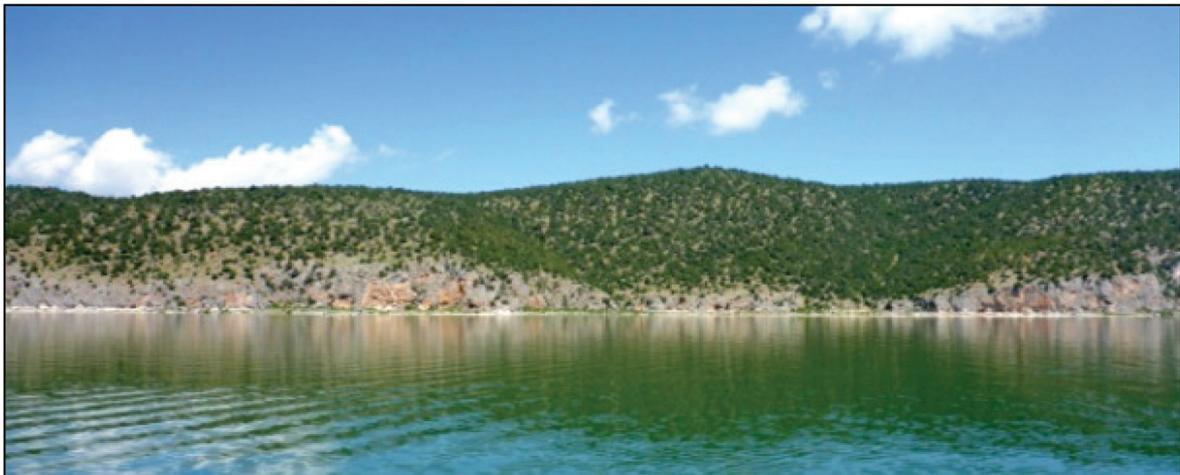
Figure 25. Example of a typology 4 shorezone: cliff

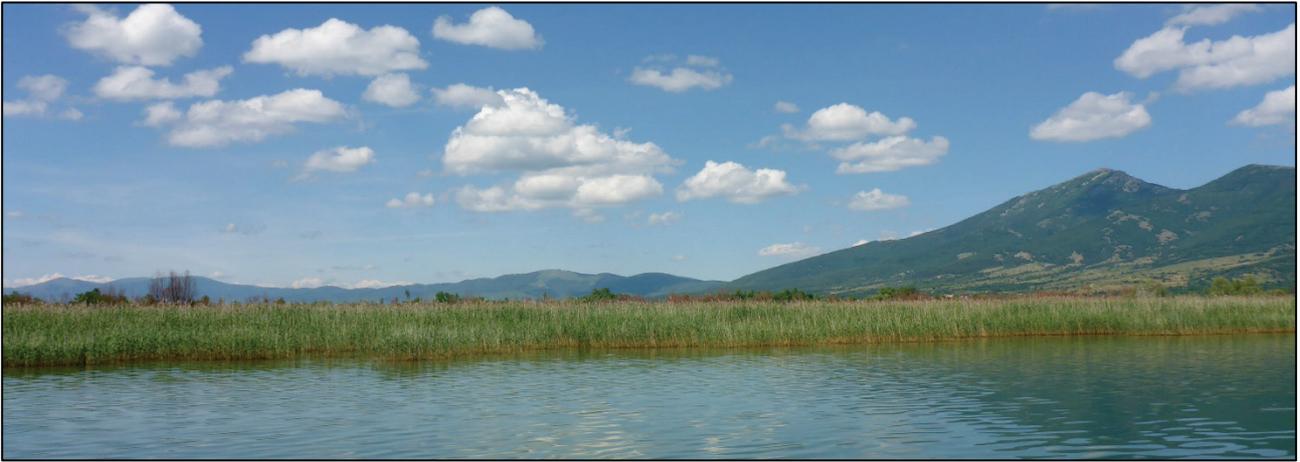
Figure 28. Example of a typology 2 shorezone: reeds only

Given the flatness of the terrain in HGM area II, reeds can grow out into the lake for hundreds of metres, which substantially increases the overall width of the functional shorezone (Figure 28).

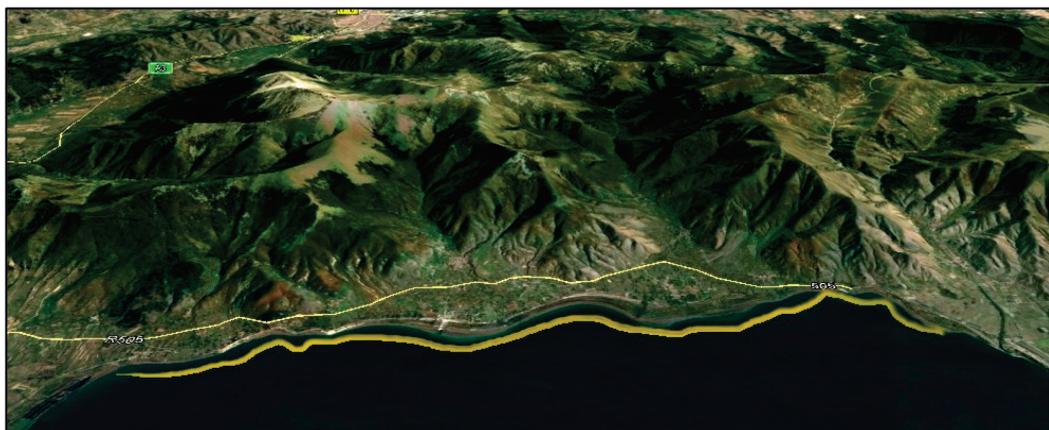
Figure 29. View of the Prespa Lake shorezone in HGM III

HGM area III is characterised by a small area of flat terrain (wider than that found on the western side of the lake in HGM area I) which is mainly used for farming (Figure 29). It is skirted to the east by the impermeable granite Baba Mountains, which contain the highest peak in the Prespa watershed, Veternica (2,420 m; Figure 30).

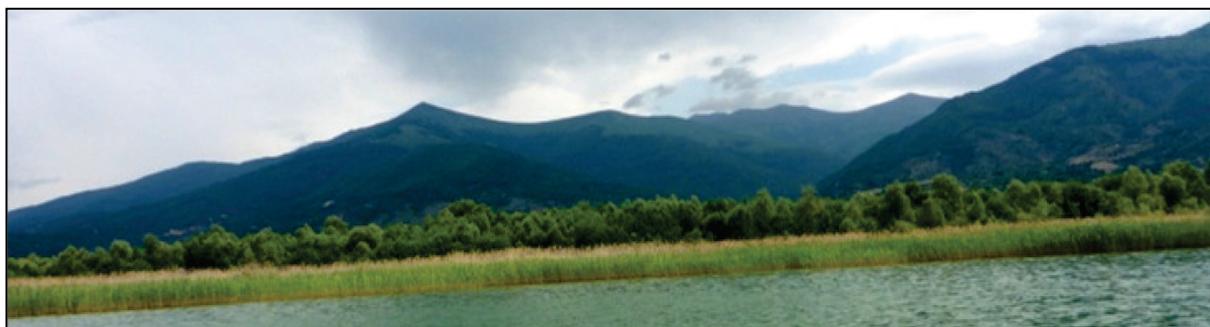
Figure 31. Example of a typology 1 shorezone: established riparian trees and belt of reeds

While agricultural fields and sparse urbanisation are present throughout the surrounding territory (i.e. the terrain up to 200 metres from the shoreline), the shorezone area is often natural and contains wide reed belts (Figure 31). The shorezone functionality is therefore naturally high, but decreases in locations where human pressure is higher.

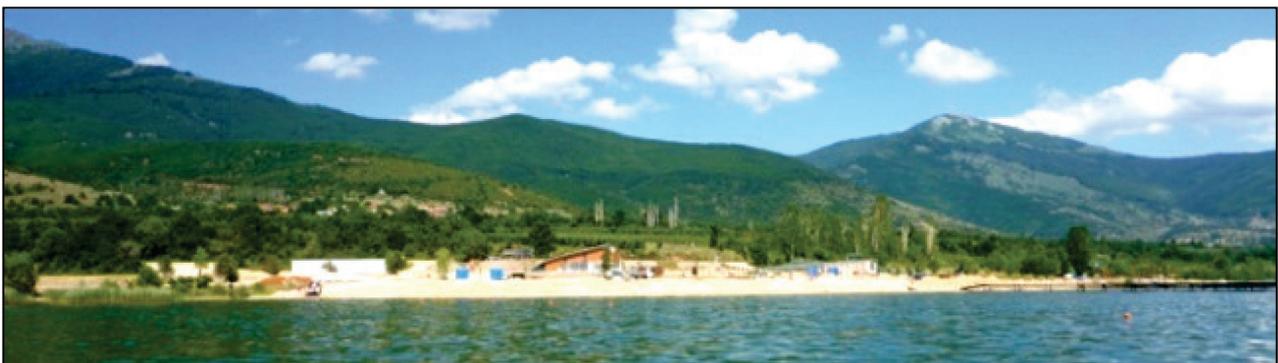
Figure 33. Example of a typology 5 shorezone: bare soil/beach with high artificiality and no functionality

The main shorezone typology present in this area is typology 1 (Figure 32). The two sites in this area where functionality is absent contain beaches (0 m functional shorezone, 100% bare soil; Figure 33).

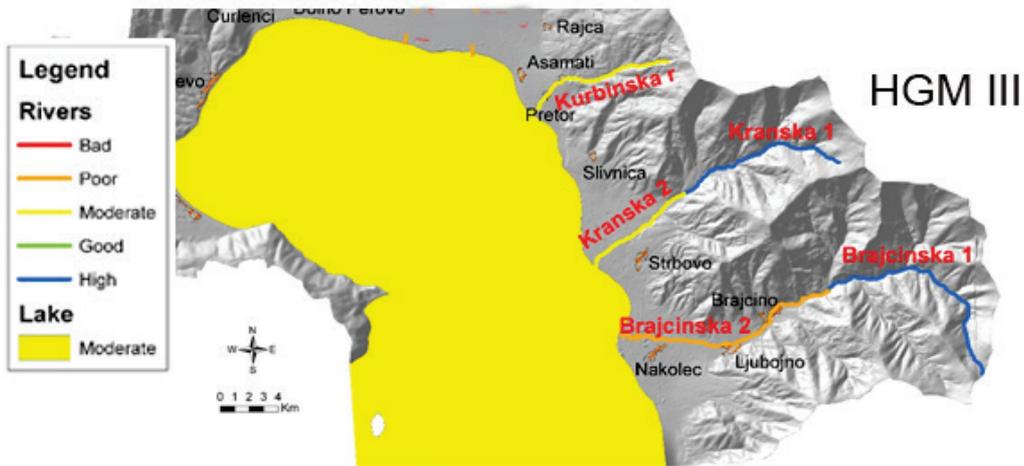
Figure 34. Map of the ecological status classifications of water bodies in HGM area III (Prespa Lake Watershed Management Plan 2012)

While the upper sections of the rivers in HGM area III have been evaluated with a high ecological status, their downstream sections are strongly affected by human activities (including domestic sewage and diffuse agriculture-related pollution) and are thus classified with a medium or poor ecological status according to the WFD classification of ecological status of surface water bodies (Prespa Lake Watershed Management Plan 2012; Figure 34).

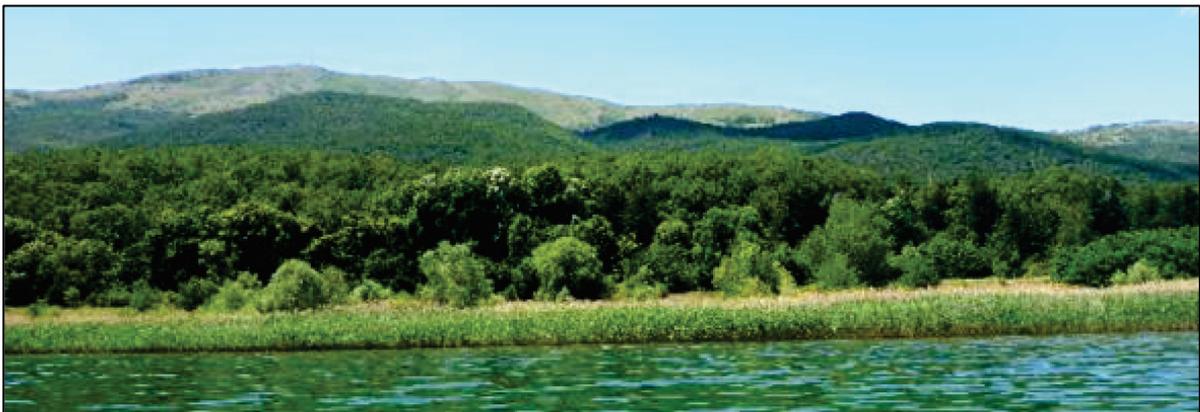
Figure 36. Established riparian trees and belt of reeds

Typology 1 is characterised by a belt of riparian vegetation (shrubs and trees), accompanied by reeds in the littoral zone, covering an area more than 50 metres wide (Figure 36). It provides a high value of complexity and functionality (SFI = 1). It is typically found in HGM area II, mainly on the eastern side of the Ezerani wetlands, and in HGM areas I and III in places where there is no human disturbance.

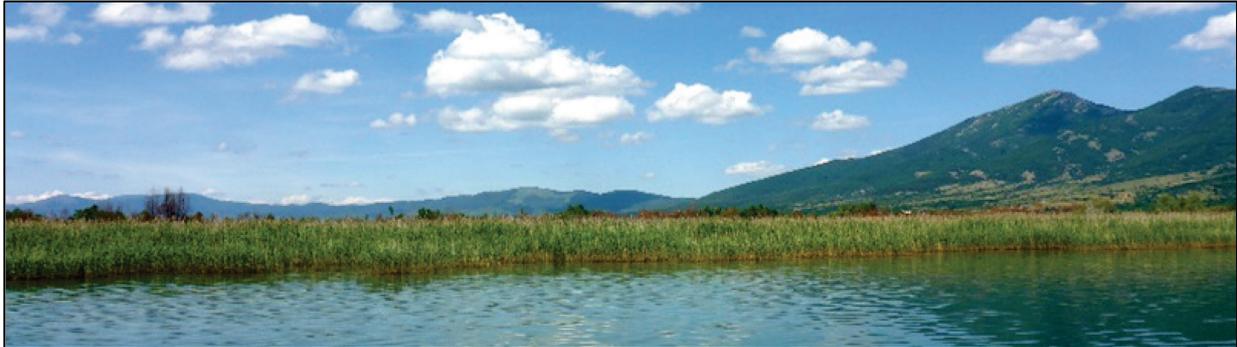
Figure 37. Wide belt of reeds along the western side of the Ezerani wetlands

In typology 2 the belt of reeds of different width runs adjacent to land that is heavily impacted by human activity. In general, this means that the land has been used for either grazing or crop growing and that its terrestrial riparian vegetation is either totally absent or present in small pockets that do not provide any ecological services.

This typology is generally found in flat bay-side areas in HGM area I and in the western section of the Ezerani wetlands in HGM area II that is populated by reeds and contains extensive apple orchards.

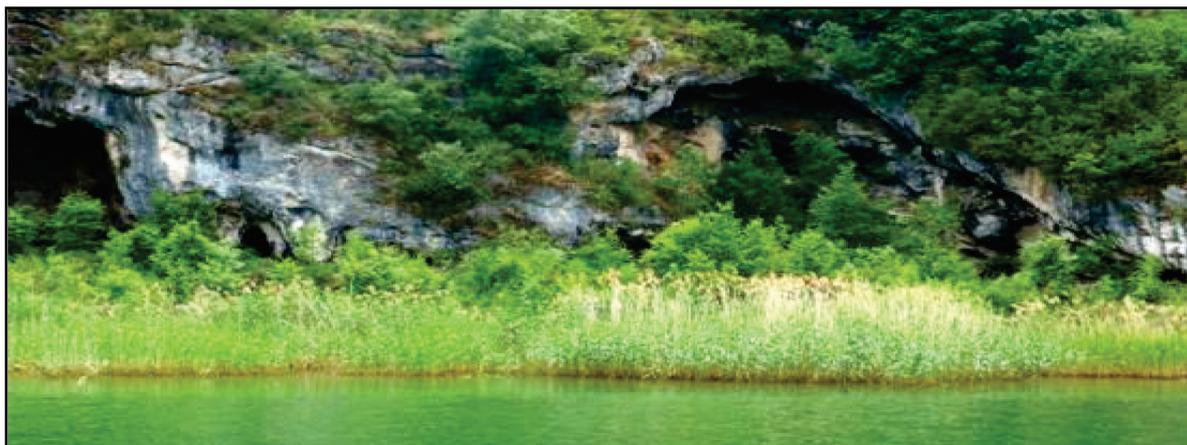
Figure 38. Cliffs with reeds

HGM area I extends from the Greek border to the Macedonian town of Stenje. The slope of the mountain-side terrain continues into the lake, which means that reeds and aquatic vegetation are either limited to the first few meters close to the shore or absent. At certain points along the shoreline, there are small flat areas where shrubs can grow on the land and reeds in the littoral zone. These thin belts of functional vegetation provide some functionality and are thus classified as category 2 (good).

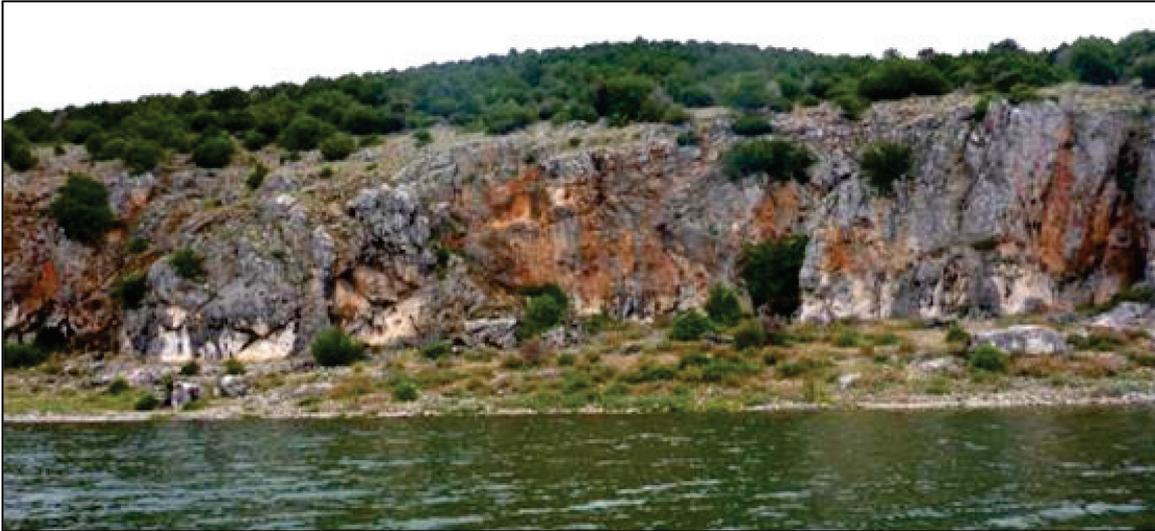
Figure 39. Cliff with bare rock

In this shorezone typology, which is typically found in HGM area I (mainly in the Albanian and in a small section of the Macedonian part), the slope of the mountain side descends almost vertically into the lake. As a result, the littoral zone is not suitable for the growth of reeds and most of the shore, therefore, appears bare and is colonised by only a few shrubs (Figure 39).

Despite the naturalness of this typology, its functionality – i.e. its capacity to function as a buffer zone for pollutants coming from the surrounding territory and/or as habitat for wildlife – is extremely low. Therefore, this typology is classified as category 3 (moderate).

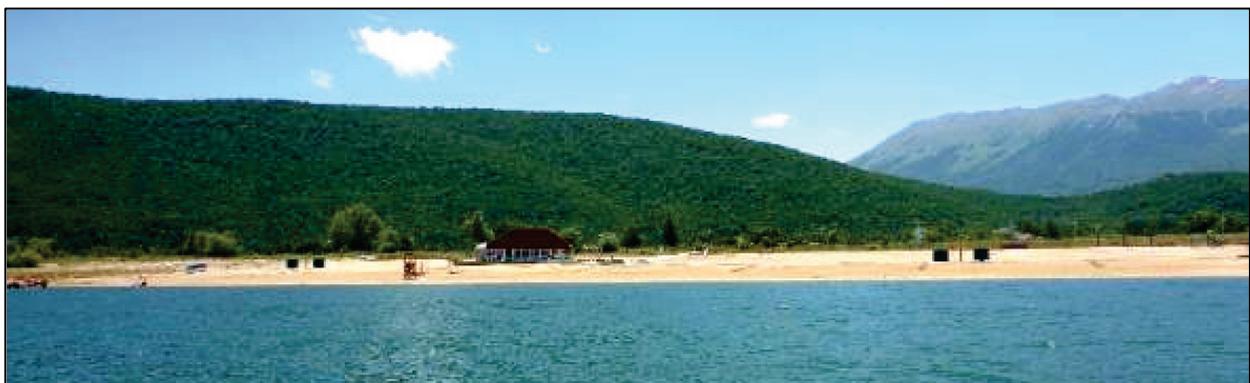
Figure 40. Bare soil/beach with high artificiality and no functionality

This shorezone typology occurs in areas strongly impacted by human activity. As Prespa Lake has no established urban settlements along its perimeter, these typologies are only found in sites containing artificial beaches, which lack any functional riparian vegetation and reeds (Figure 40). Typology 5 stretches are therefore classified as category 5 (bad).

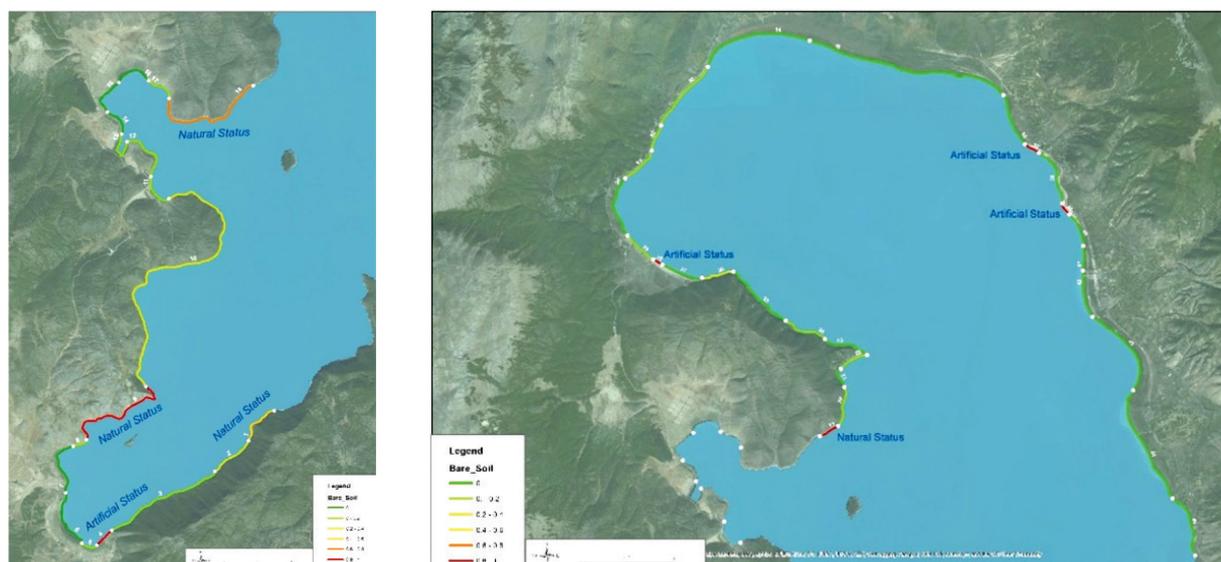
Figure 44. Artificial and natural status shores that correlate with stretches containing a high percentage of bare soil (between 80% and 100%)

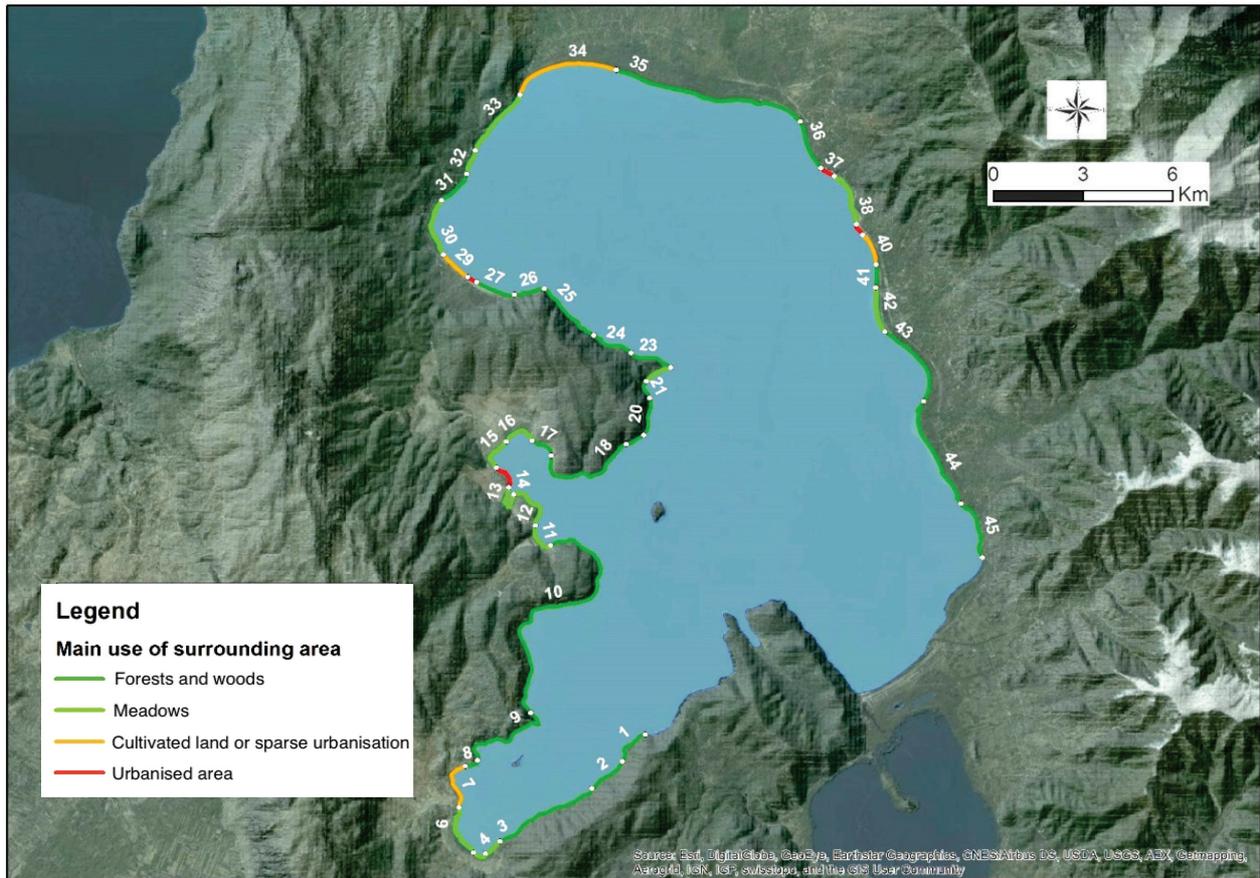
Figure 46. Anthropogenic use of the surrounding territory (0 to 200 metres inland from the shoreline)

Figure 46 depicts the prevalent human activities in an area running from the shoreline to 200 metres inland. It also indirectly indicates any repercussions on the shorezone’s functionality occurring as a result of the modification of the surrounding soil that can increase the input of nutrients, organic matter and pollutants or change the natural permeability of the soil.

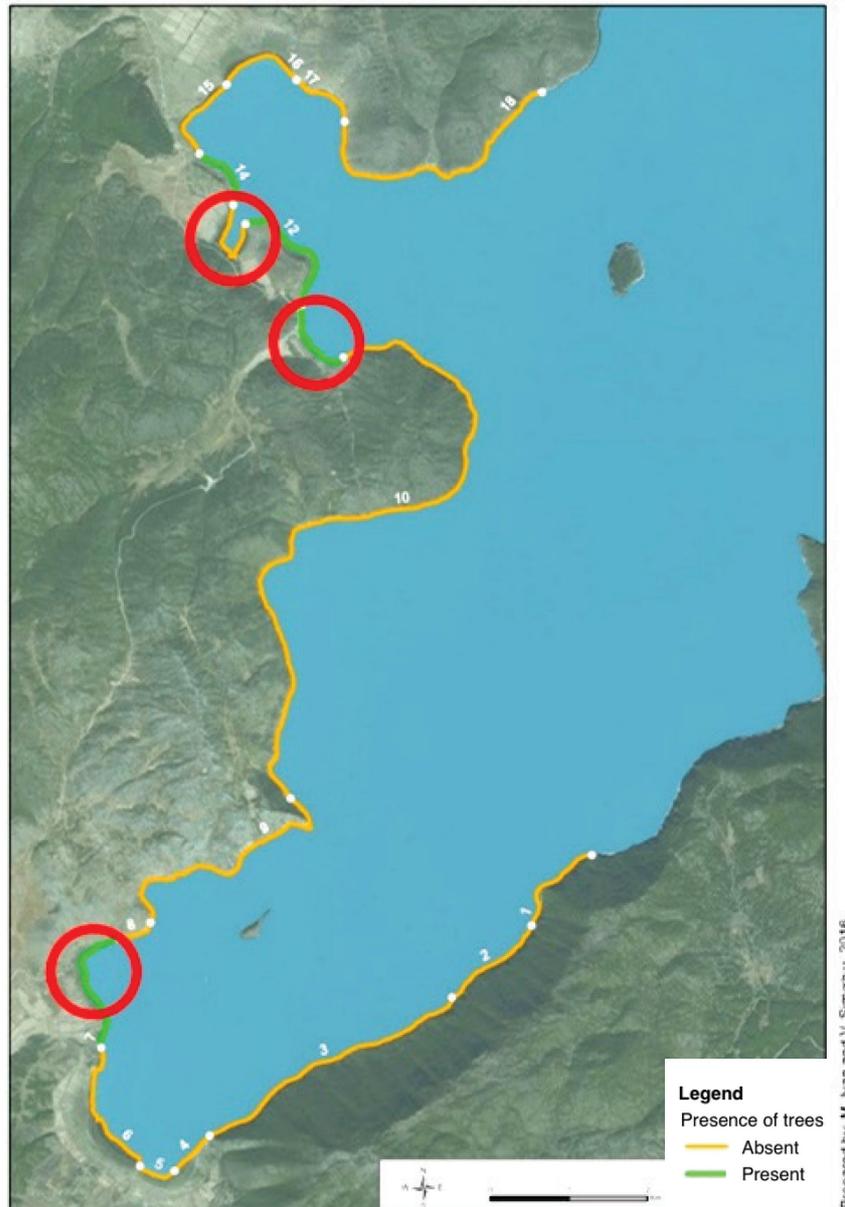
Figure 51. Presence (green line) and absence (orange line) of trees along the Albanian shore, with areas that should be protected and fenced off to deter grazing circled in red
