Shorezone Functionality

Skadar/Shkodra Lake

Implementing the EU Water Framework Directive in South-Eastern Europe

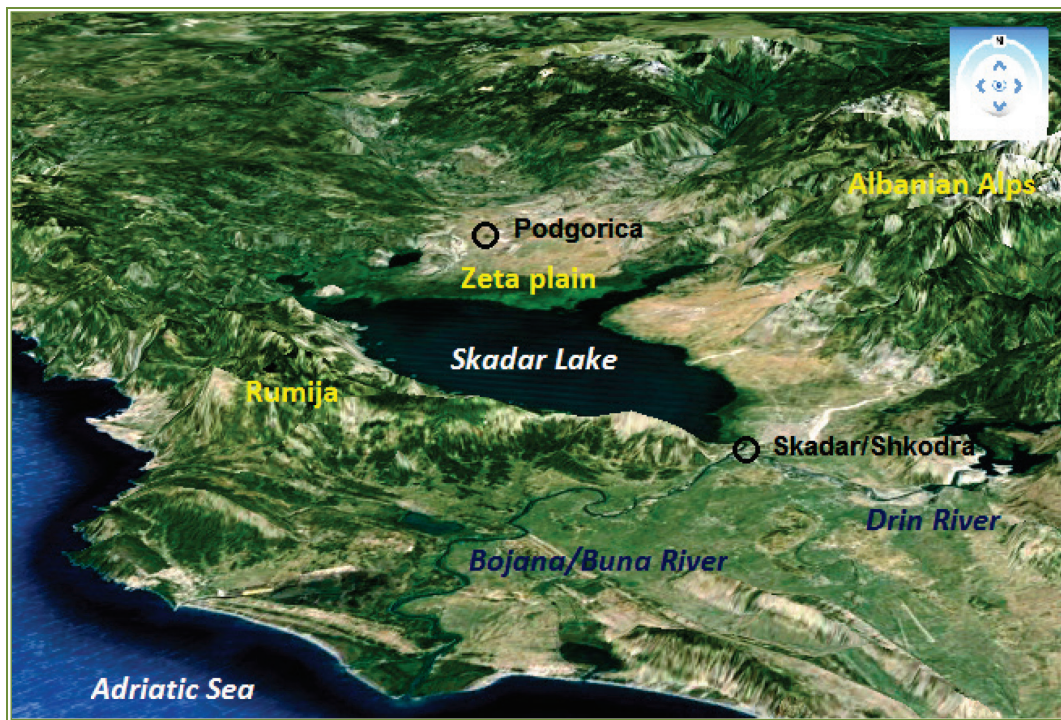
Figure 11. 3D view of the Skadar/Shkodra Lake sub-basin (Google Maps 2016)

The basin (Figure 11) is a depression running northwest–southeast, parallel to the Adriatic coast. The Zeta Plain in Montenegro extends northward from the lake, and the Albanian Alps rise up to its east. The lake coast is flat on these northern and eastern sides. The southwestern coast is defined by the ridges of the Sutorman, Rumija and Tarabosh Mountains, and is therefore steep and rugged. It is this mountainous zone that separates the lake from the Adriatic Sea. The only outflow from the lake is the Bojana/Buna River, which for most of its length also forms the border between Montenegro (MNE) and Albania (AL).

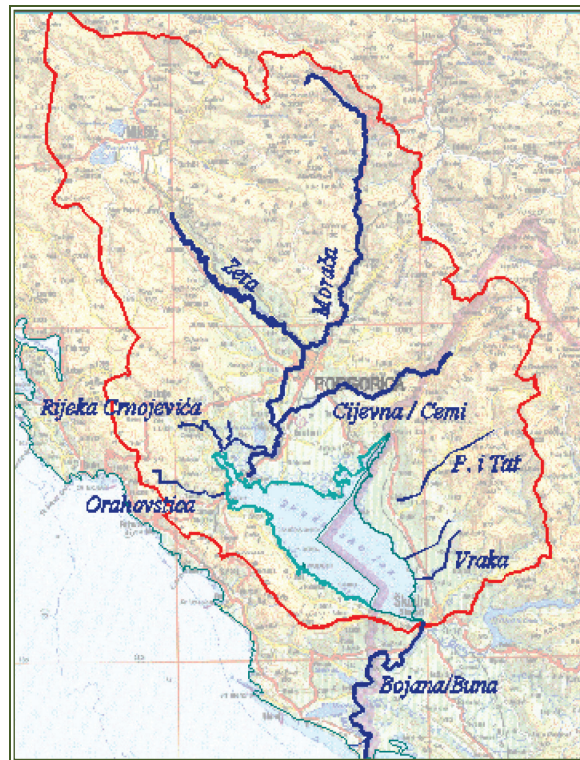
Figure 14. The main tributaries of Skadar/Shkodra Lake

The main tributary of the lake is the Morača River, which itself has two tributaries: the Zeta and Cijevna/Cemi Rivers. The 99-kilometre long Morača flows through Montenegro's capital city of Podgorica, drains about 32% of the Montenegrin territory and provides 62% of the lake's water (Radulović 1997). Other important tributaries are the Crnojevica, Orahovstica, Karatuna and Baragurska Rivers on the northern coast of the lake in Montenegro, and the Përroi i Thatë, Rjolska and Vraka Rivers in Albania. Smaller streams flow into Skadar/Shkodra Lake from its western side. Together, all these tributaries contribute 11% of the total water input (see Table 11 on the water balance).

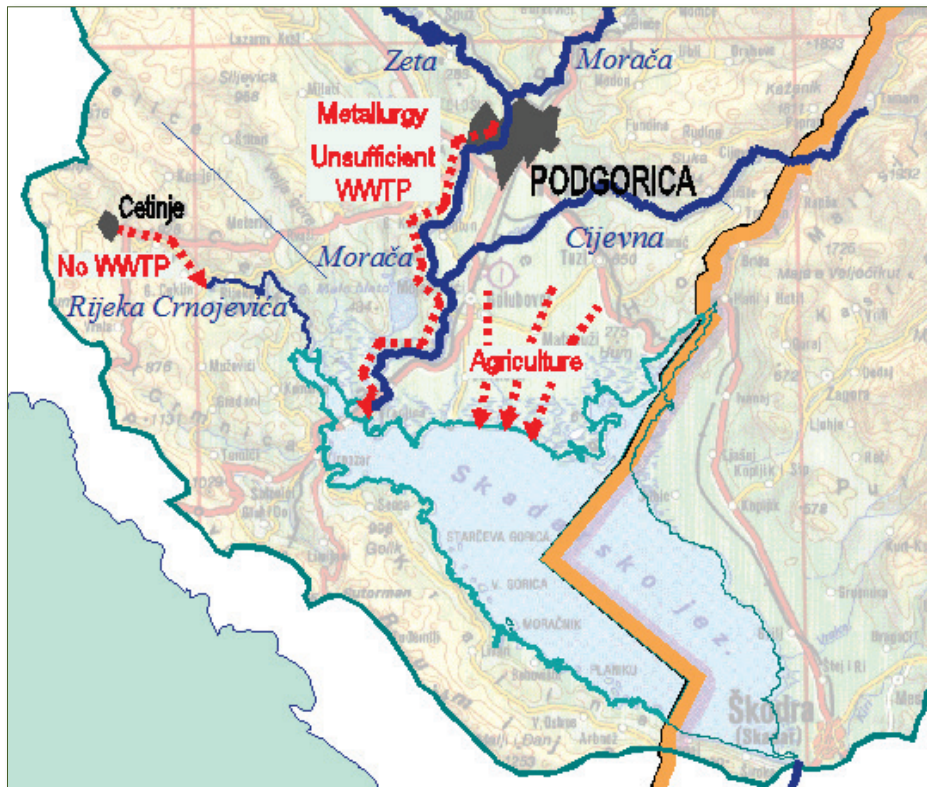
Figure 19. The main pollution pressures on the Montenegrin side of the lake

Aside from the diffuse pollution caused by agriculture, the largest inflow of nutrients comes from Podgorica's wastewater treatment plant (WWTP). Of the annual 10.2 million m³ of wastewater generated in the area of Podgorica, this treatment plant processes only 60%. The remaining 40% is discharged without treatment. The lakeside settlements Virpazar and Vranjina have built their own WWTPs. However, the town of Cetinje, which is located in the catchment area of the Rijeka Crnojevića tributary, does not have a WWTP, which means that pollution enters the tributary at its headwaters (Šundić, R. 2012).

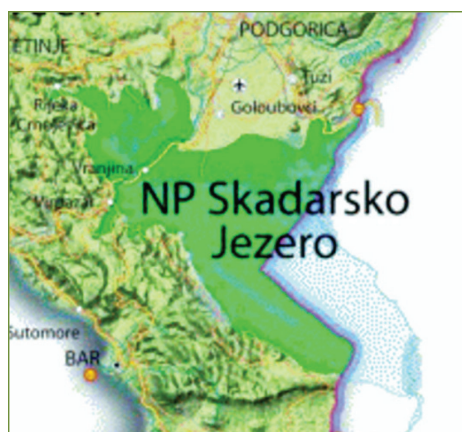
Figure 20. The territory of Skadar Lake (Skadarsko Jezero) National Park

Skadar Lake National Park contains 7,800 ha of permanently inundated land, 5,200 ha of intermittently inundated land, and 812 ha of bird reserve (REC 2003).

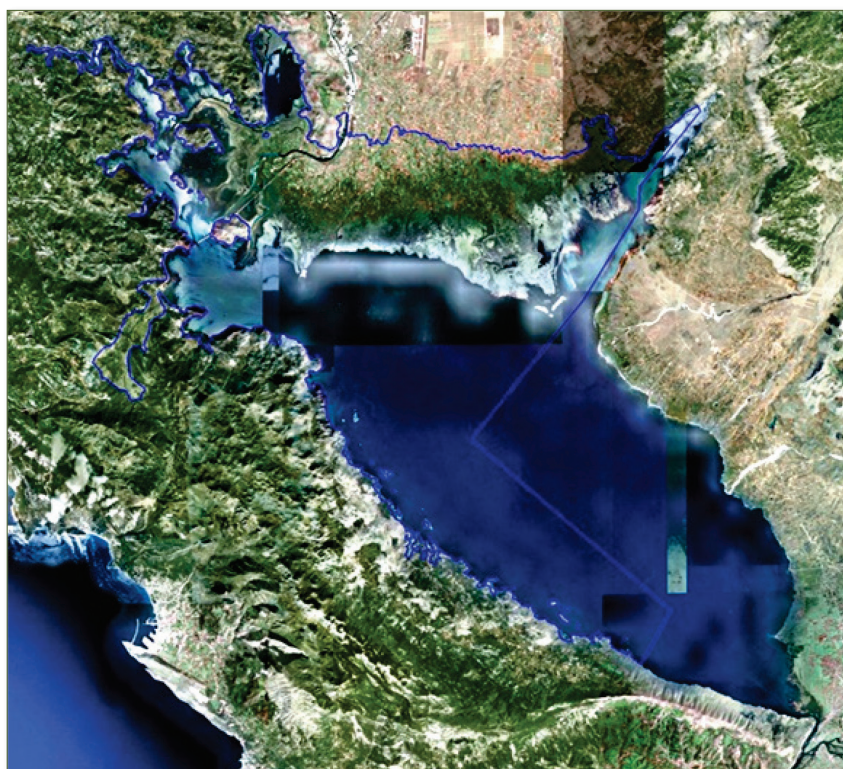
Figure 21. The territory around Skadar/Shkodra Lake that was flooded in winter 2010/2011, when high waters were augmented by the release of water from dams on the Drin River (Water Directorate of Montenegro, 2011)

Due to the limited capacity and gentle gradient of the Bojana/Buna River channel, in times of high water the discharge from the Drin River prevents Skadar Lake from discharging into the Bojana/Buna and ultimately into the Adriatic Sea. Consequently, Skadar Lake's water levels rise, leading in exceptional circumstances (which are often exacerbated by anthropogenic factors) to flooding in areas deep into the hinterlands north of the lake.

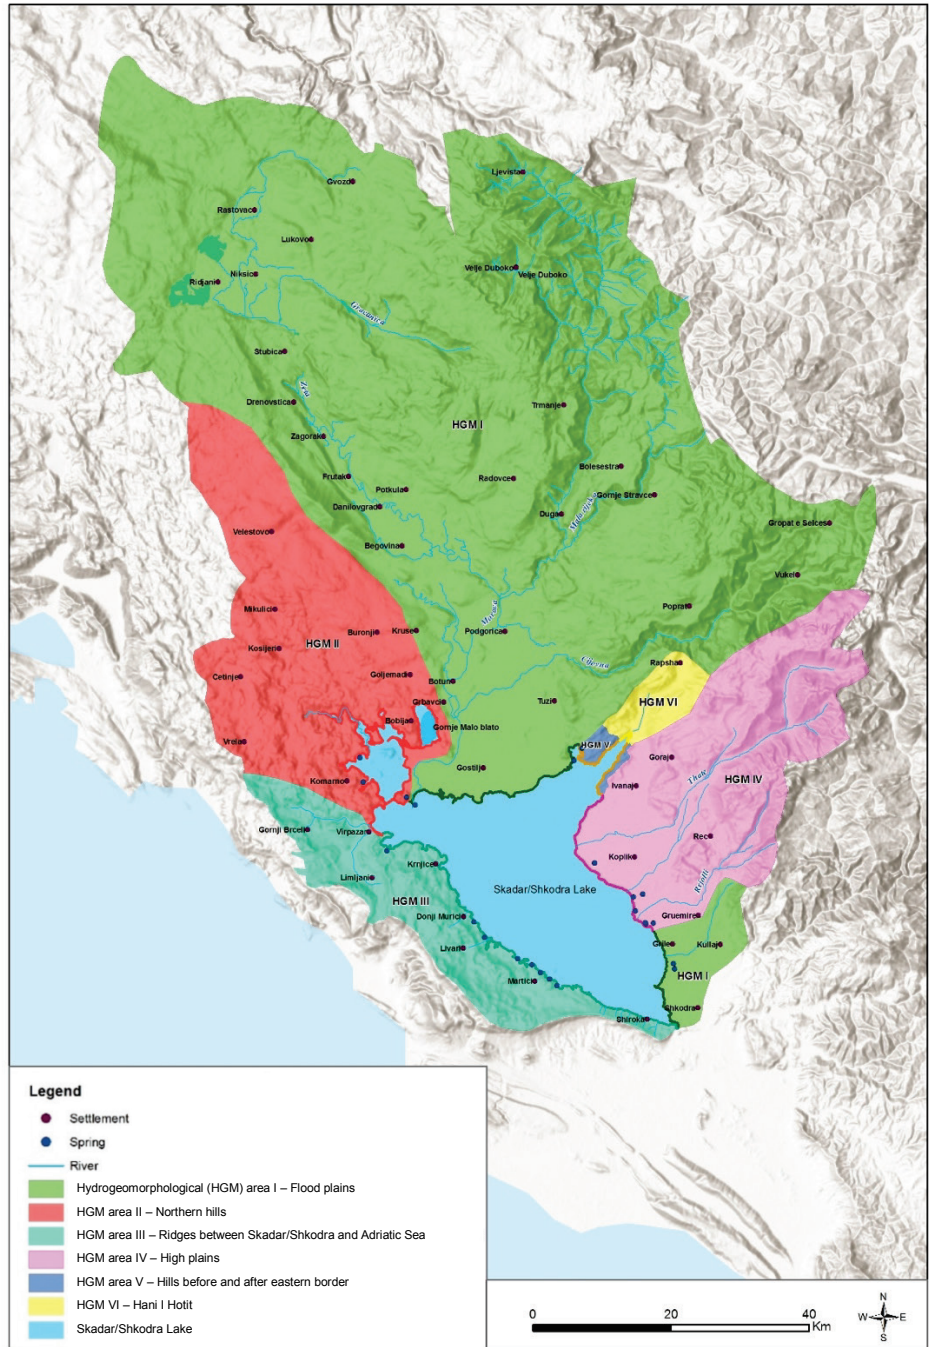
Figure 24. The six main HGM areas

Six main hydrogeomorphological (HGM) areas have been identified. They are characterised by different geological, hydrological and morphological factors. These factors represent either an advantage for or a limitation to the natural growth of a functional shorezone and, in cases where anthropogenic pressures do not represent the major limiting factor, the SFI results often reflect the nature of the HGM areas.

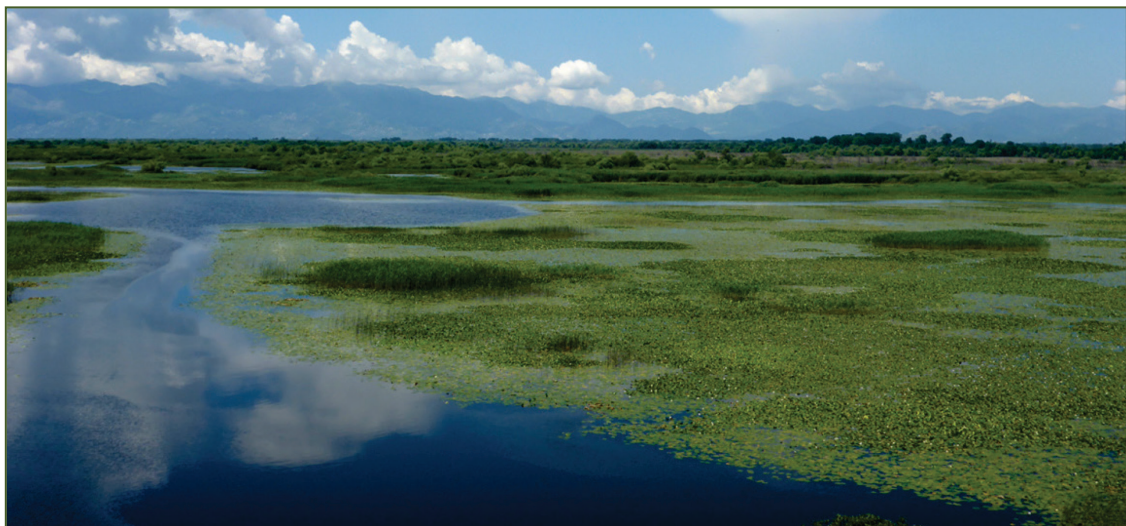
Figure 28. Example of a functionality category 1 shorezone in the Montenegrin section of HGM area I

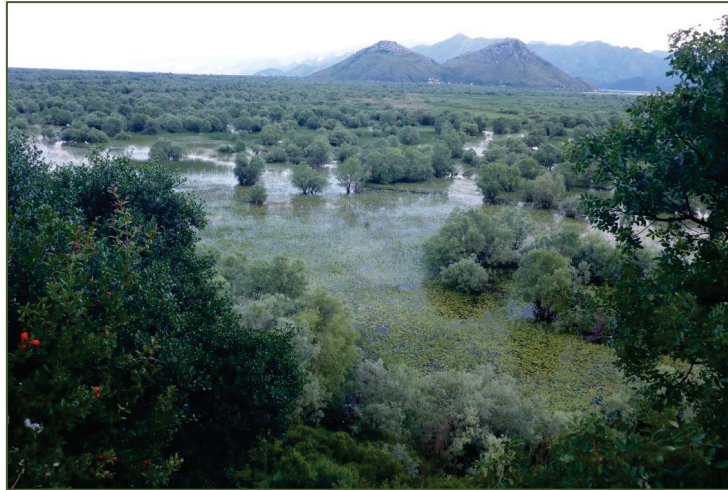
Morača River, the main tributary, flows into the lake from the Zeta Plain. This river provides 62% of the lake’s water and its nutrient load can seriously affect the lake’s ecological status.

Fortunately, the shorezone functionality in this HGM area is high, meaning it has a high capacity for nutrient removal. In addition, it provides a variety of habitats for aquatic and terrestrial fauna.

Figure 29. Alluvial area located near the mouth of Morača River in the Montenegrin section of HGM area I

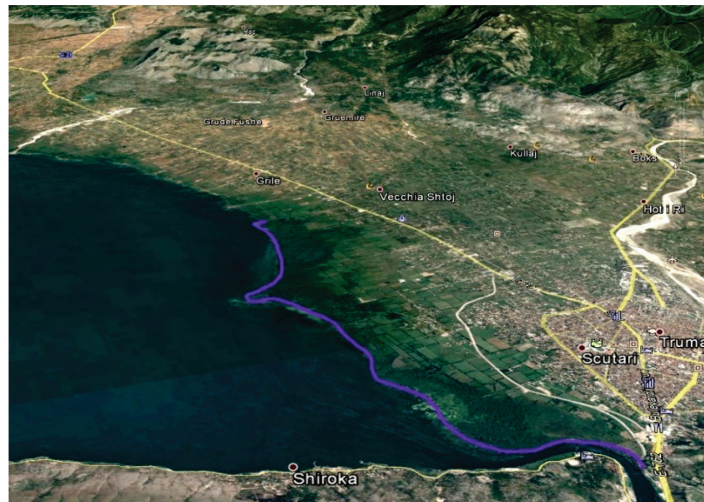
Figure 30. Functionality category 1 in the Albanian section of HGM area I

The Albanian section of HGM area I is located just to the west of Shkodra city. As anthropogenic disturbance is absent in this zone, the riparian vegetation can grow undisturbed and the shorezone functionality is high. It therefore has a high capacity for nutrient removal and provides a variety of habitats for aquatic and terrestrial fauna. As such, it represents an important buffer zone that is capable of filtering out some of the pollution emanating from the city.

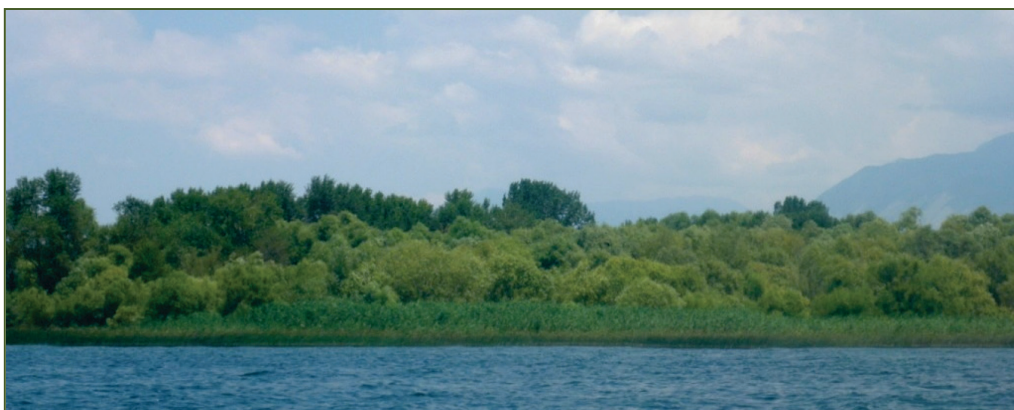
Figure 31. Example of a functionality category 1 shorezone in the Albanian section of HGM area I

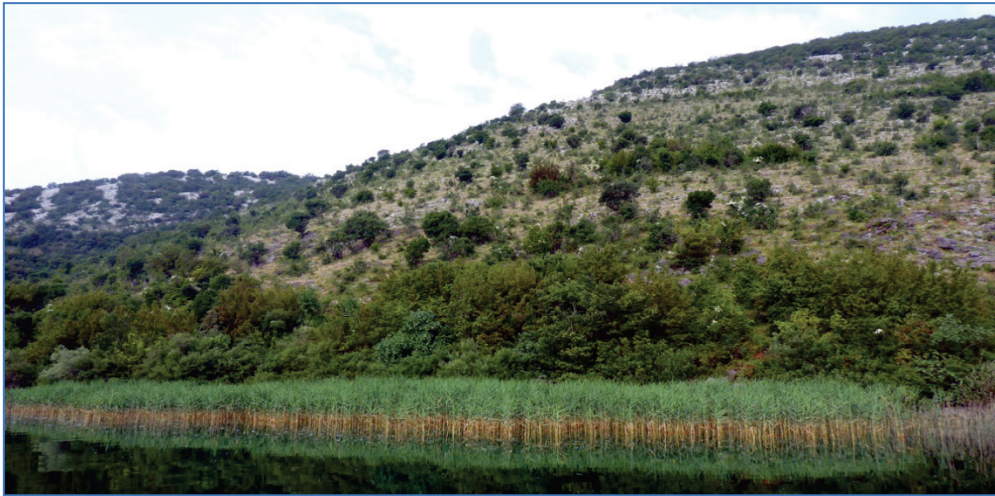
Figure 35. Example of a functionality category 2 shorezone in HGM area II

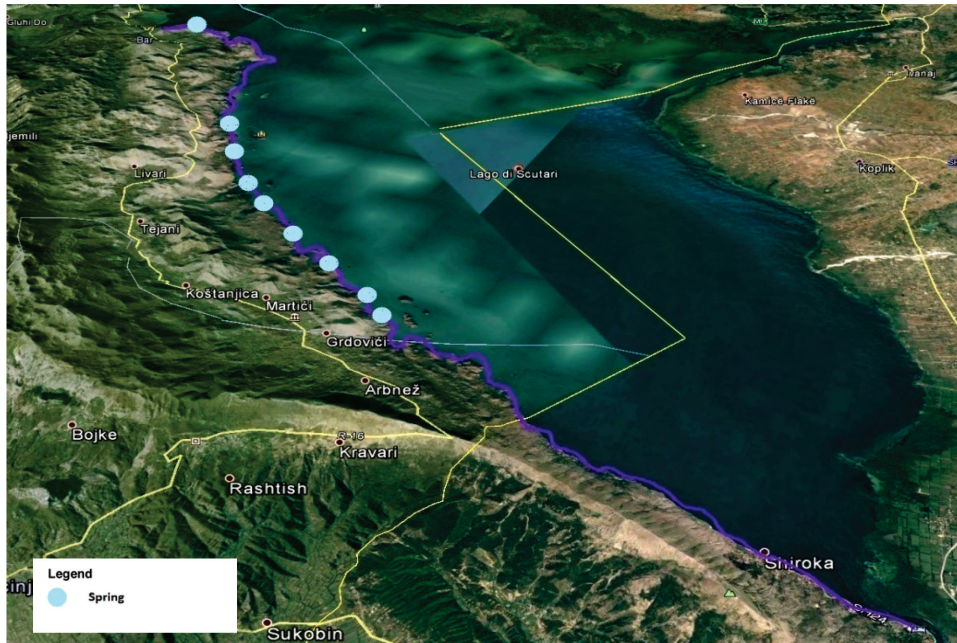
Numerous springs are present along this shore and they constitute the main source of water input from this area (Figure 37).

Figure 37. The terrain and main springs in HGM area III

The sloping topography of the shore affects the growth of riparian vegetation, which can only grow close the shoreline in a belt a few metres wide, and because the slope continues below the waterline, reeds cannot grow in this area. All these factors limit the width of the functional shorezone to a few metres. The filtering capacity of this shorezone is therefore limited, as is its capacity to provide habitats for aquatic and terrestrial fauna.

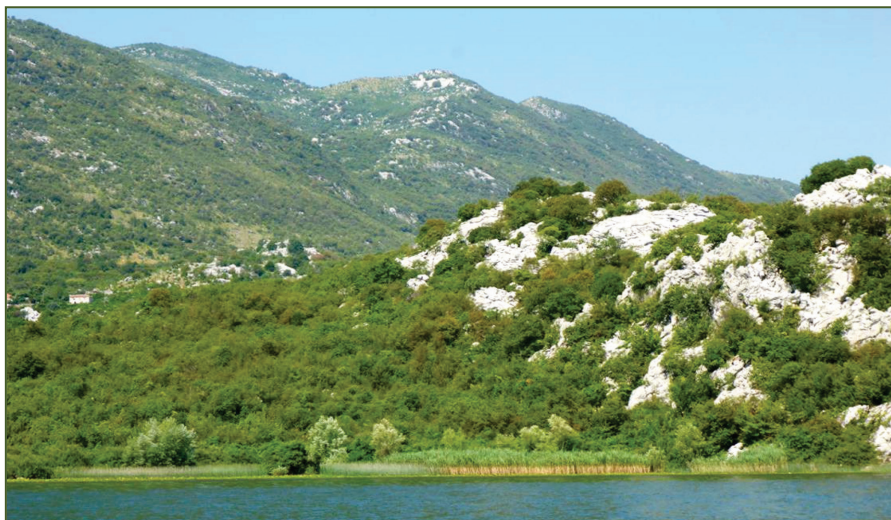
Figure 38. Example of a functionality category 2 shorezone in the Montenegrin section of HGM area III

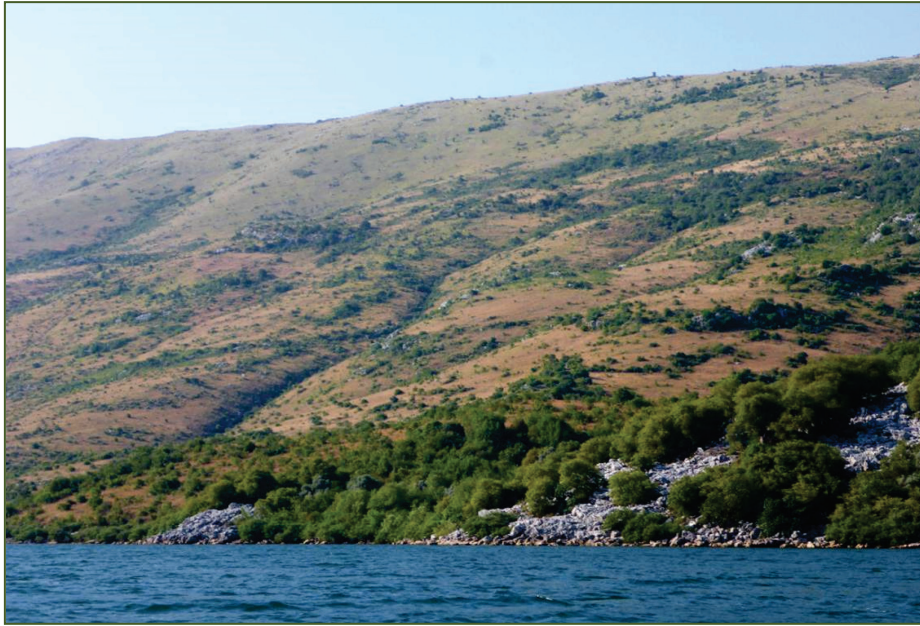
Figure 39. Example of a functionality category 3 shorezone in the Albanian section of HGM area III

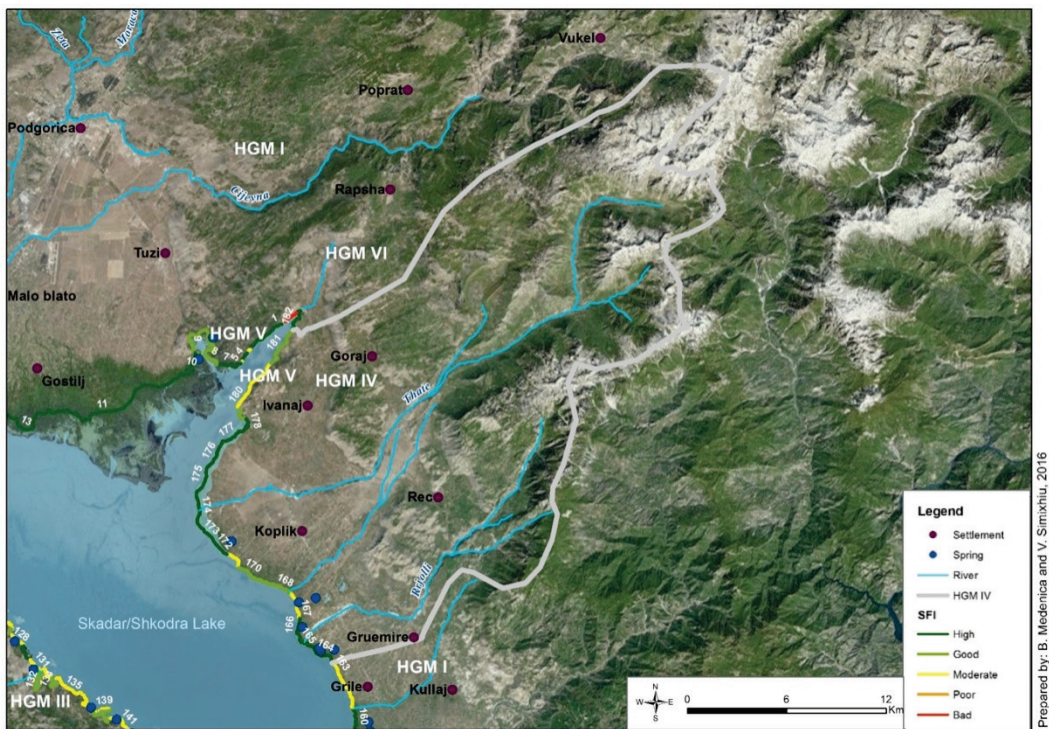
Figure 40. Catchment area of HGM area IV – High plains

HGM area IV is located on the Albanian plains to the east of the lake, close to the settlement of Koplik.

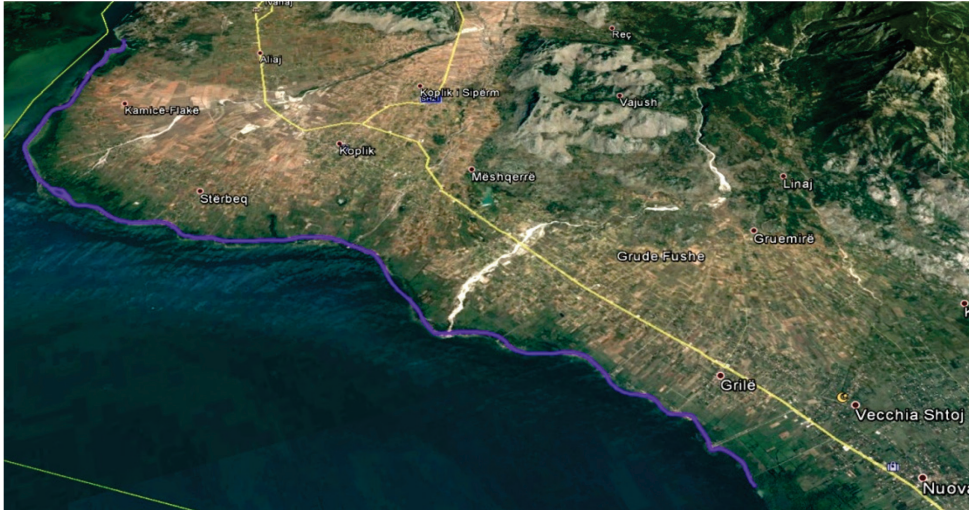
Figure 41. HGM area IV – High plains

These plains are slightly higher than those found in HGM area I and are therefore not subject to periodic flooding from the lake. While the area is mainly used for agriculture, some tourism infrastructure is also present along the shore.

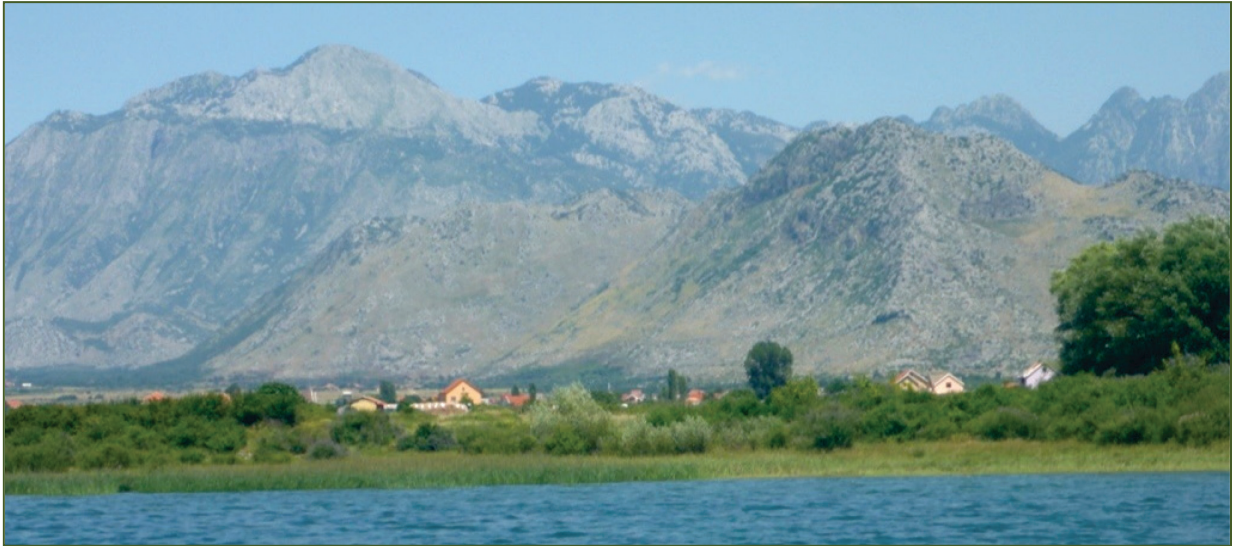
In this area, reeds are not as frequent as in HGM area I. Closer to the town of Koplík, agriculture extends very close to the shore, which limits the width of the functional shorezone and reduces SFI values (moderate and good).

Figure 43. Example of a functionality category 3 shorezone in HGM area IV – Bare soil and limited shorezone width

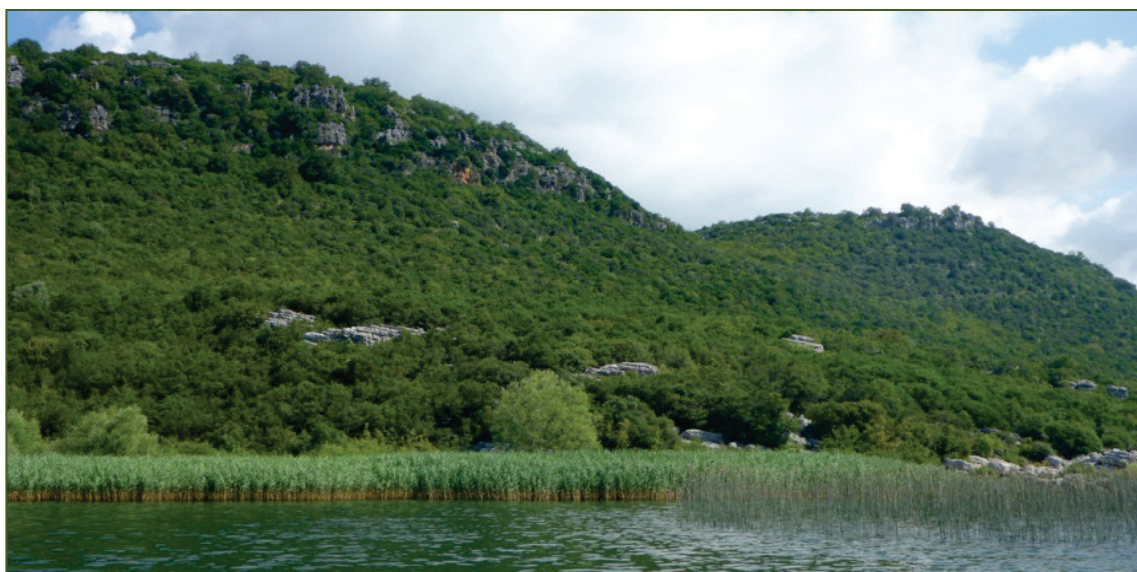
The Montenegrin section of the lake in this area is typically classified as shorezone typology 1, as the shallower waters enable more vegetation to grow. The Albanian side is, however, typically classified as typology 2 or 3, as riparian trees are mainly replaced by scattered shrubs and the surrounding territory is less verdant.

Figure 45. Example of a functionality category 1 shorezone in the Montenegrin section of HGM area V

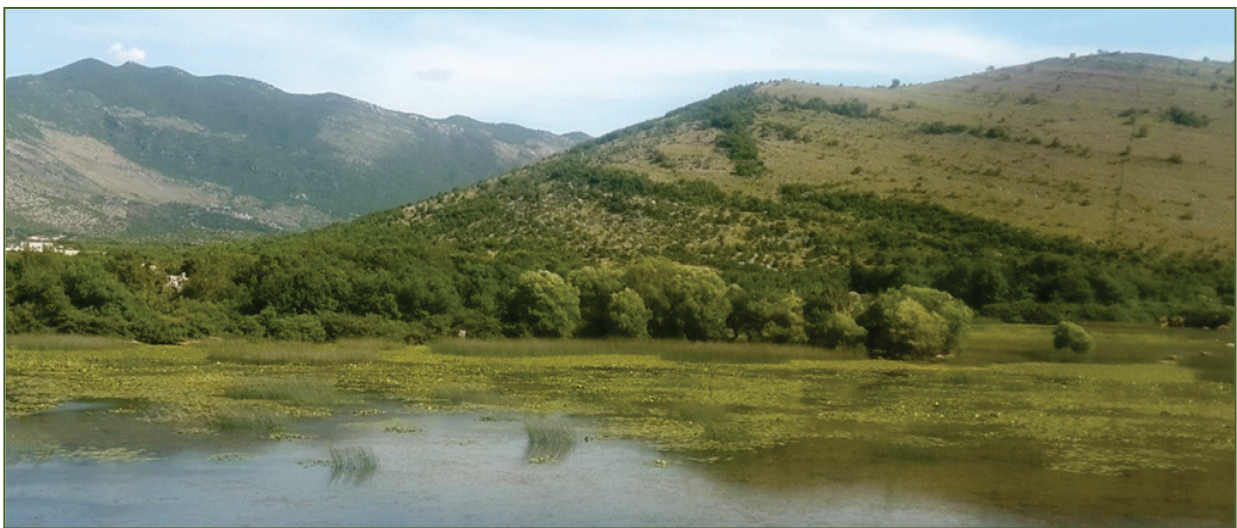
HGM area VI is located close to Albania’s eastern border and comprises the small plain of Hani i Hotit. This area has only one homogeneous stretch, which is characterised by marshland (category 1). Different to HGM area V, the surrounding territory is flat and is farmed by several families who have plots here.

Figure 48. Example of a functionality category 1 shorezone in HGM area VI, Albania

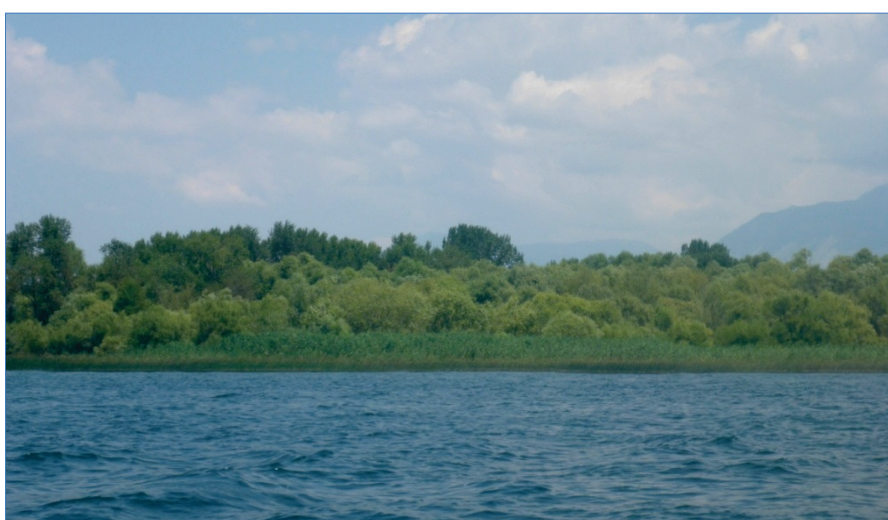
Figure 49. Example of a typology 1 shorezone: riparian vegetation (shrubs and trees), with or without reeds, more than 50 m wide, natural, with a high level of complexity and functionality

Typology 1 is characterised by a thick belt (> 50 metres wide) of riparian vegetation (shrubs and trees), sometimes accompanied by reeds in the littoral zone. It provides high levels of complexity and functionality (SFI = 1) and is typically found in HGM areas I-A and I-M (where A = Albania and M = Montenegro).

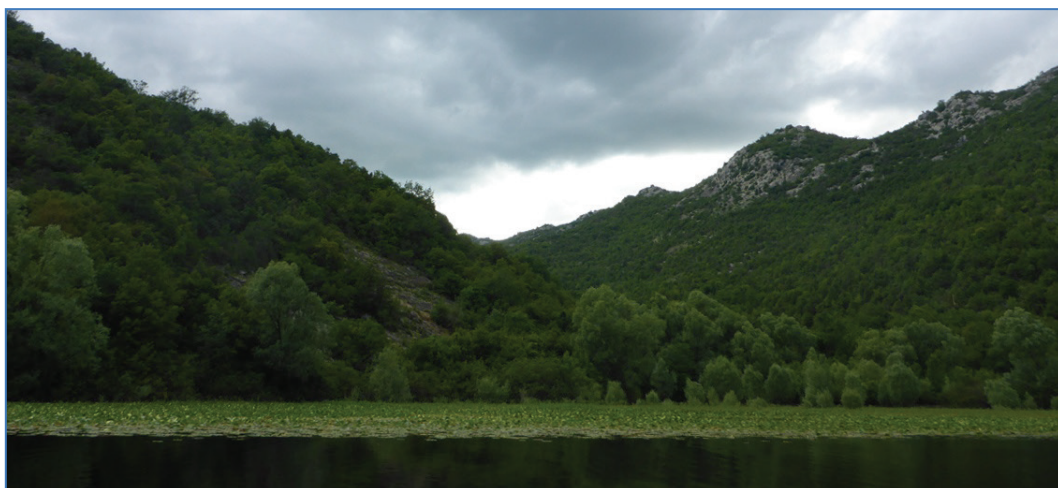
Figure 50. Example of a typology 2 shorezone: riparian vegetation (shrub and trees), with or without reeds, a width of 10 to 30 m, 100% natural, and a good level of complexity and functionality

Typology 2 is typically found in HGM areas II-M, V-A, V-M, mostly in the northern and north-western parts of the lake.

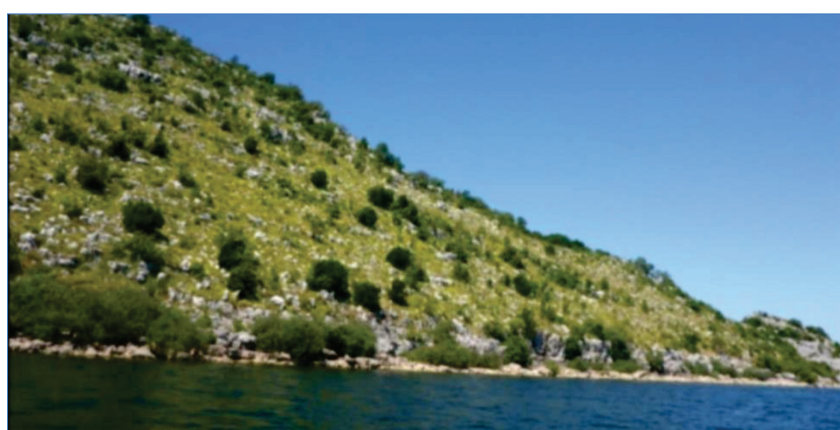
Figure 51. Example of a typology 3 shorezone: the shrubs have low functionality, the shorezone is less than 10 m wide

The limited growth of riparian vegetation is also, in certain stretches, due to high levels of anthropogenic pressure, such as uncontrolled grazing, that have occurred in the areas in question. This typology falls into the moderate SFI category (SFI = 3) and it is typically found in HGM areas III-A and III-M, which are mostly located on the western side of the lake.

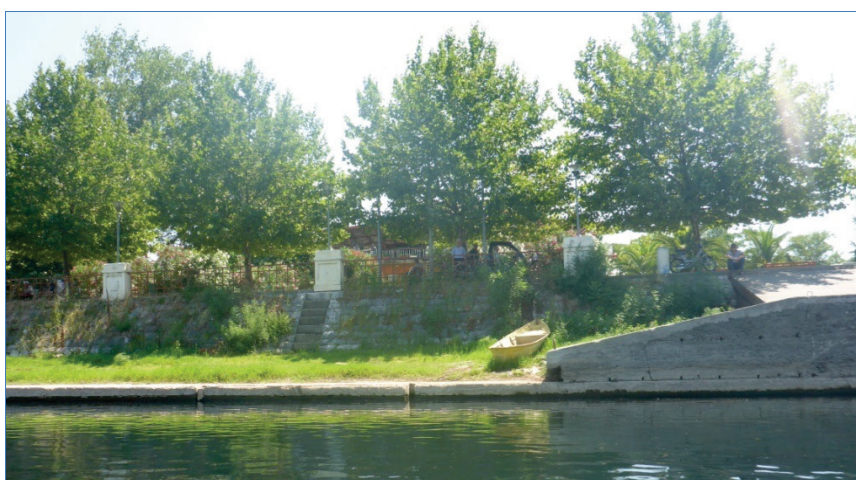
Figure 53. Example of a typology 5 shorezone: artificial

A mortar-bonded wall along the shorezone reduces its functional width to zero, limiting the buffering capacity of the riparian zone and interrupting its ecotone role between aquatic and terrestrial environments. Typologies 5 and 6 are found mostly in semi-urbanised or urbanised areas, which appear in a dispersed form all around the lake and in a concentrated form in the north-western section and the southern end of the lake.

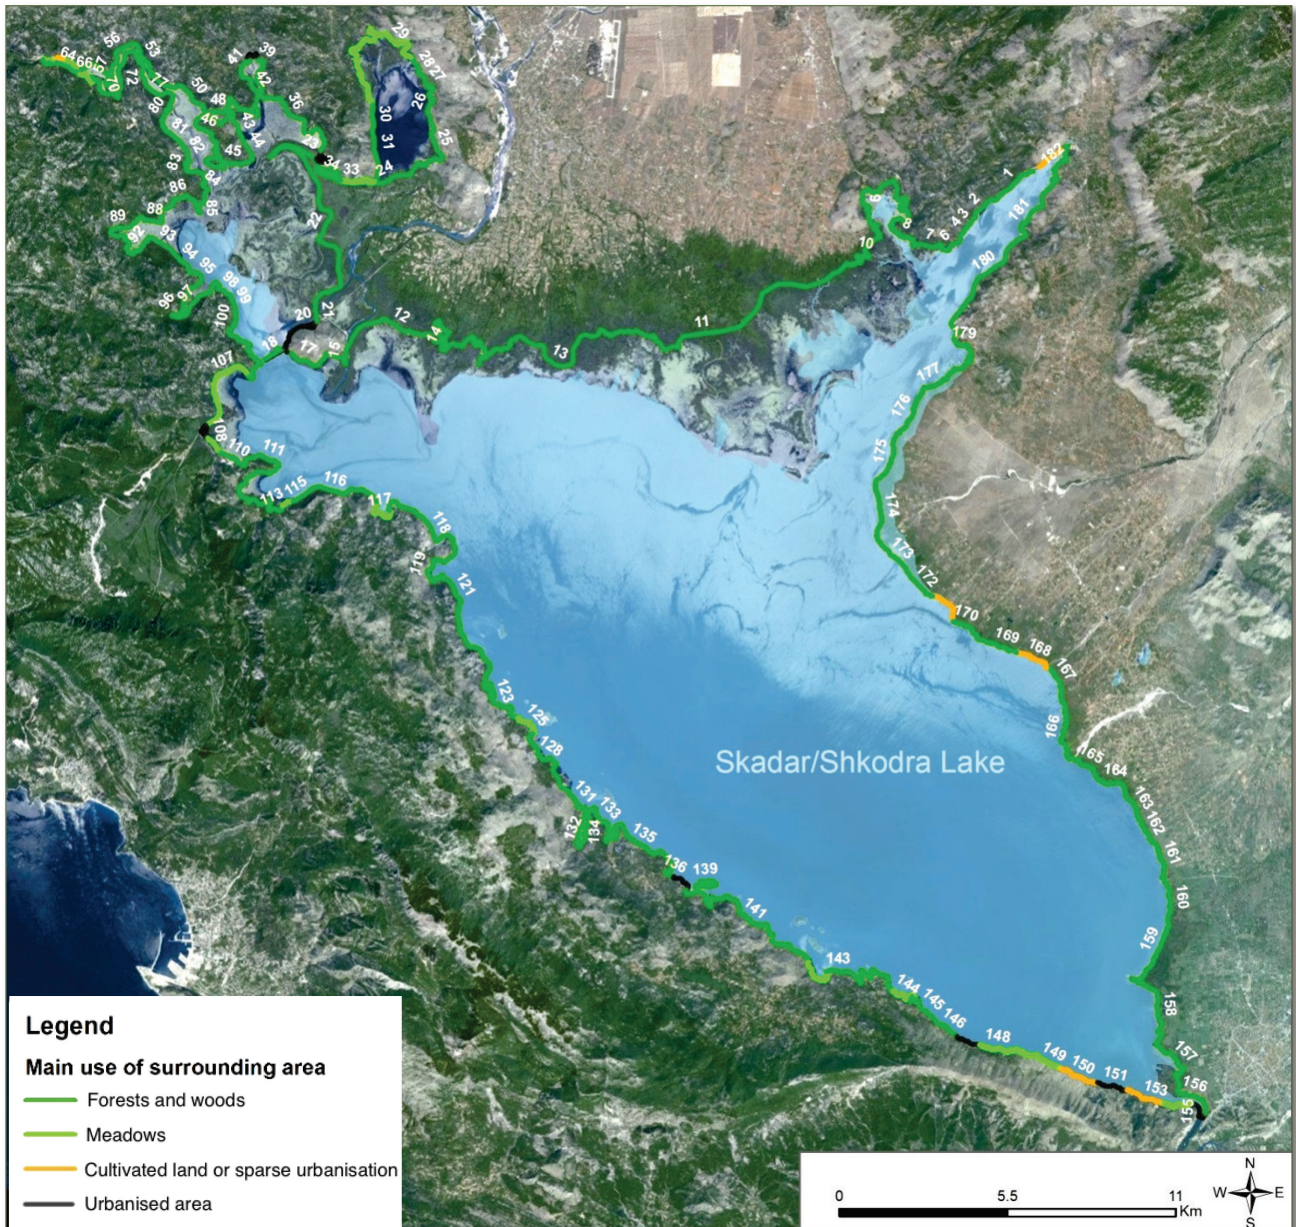
Figure 58. Anthropogenic use of the surrounding territory (0 to 200 metres inland from the shoreline)

The map of the main uses of surrounding areas reflects, in part, the data shown on the map of main types of anthropogenic use. Figure 58 describes the prevalent human activities occurring in the area running from the shoreline to 200 metres inland. It therefore indirectly indicates any repercussions on the shorezone’s functionality occurring as a result of the modification of the surrounding soil that can increase the input of nutrients, organic matter and pollutants, and can change the natural permeability of the soil. The prevalent human use present in each identified homogeneous stretch is adopted as the use for that stretch.

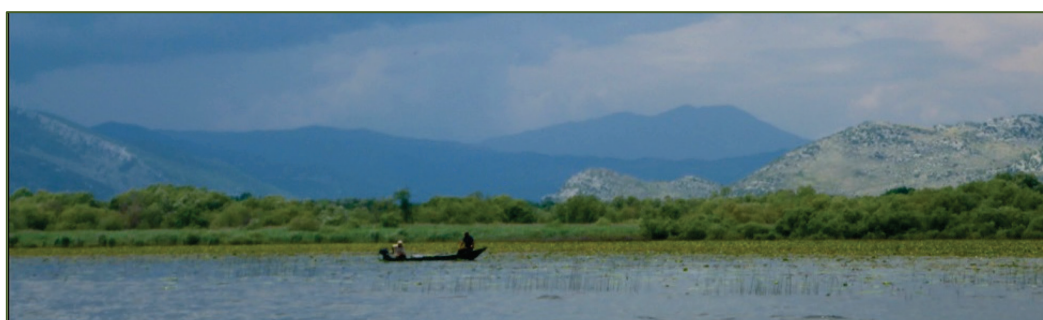
Category 1 areas are mainly found in the northern part of the lake where the environment is more pristine, there is less urbanisation, and there is a wide belt of white willow (*Salix alba*) mainly interspersed with narrow-leaved ash (*Fraxinus oxycarpa*) and wide reed beds along the shoreline, adjacent to the tree line.

Figure 61. Example of the flat, non-urbanised shore in the northern part of the lake that is classified as SFI category 1

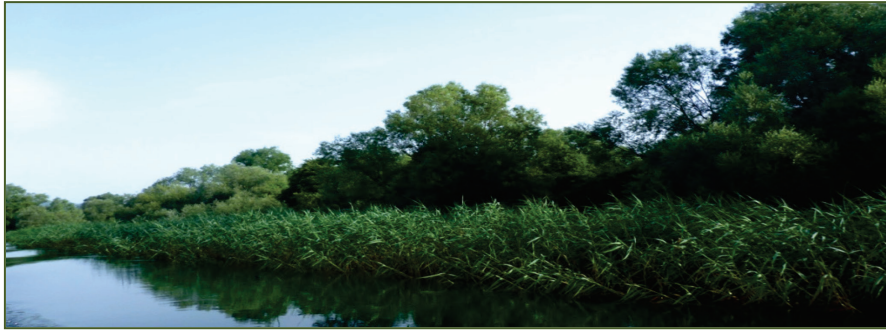
A large area of the lake's Montenegrin shorezone (34 stretches, about 26.2% or 54.7 km) is classified as SFI category 2 (good). It is characterised by consistent shoreline that is predominantly covered by dense native and mainly hygrophilous (arboreal-shrub and reeds) vegetation, which grows without interruption along the lake shore. A large part of the category 2 shoreline is found in (a) the north-west, in the natural area of Rijeka Crnojevića (Šanik, Pavlova Strana, Rudina, Prevlaka), which is in HGM area II, and (b) the northern part of the lake (Podhumski Zaliv Bay to Plavnica), which is split between HGM areas I and V. Also, a large number of category 2 stretches are found in bays situated in the south-western part of the lake where the shorezone is flat or has a very gentle gradient, and contains hygrophilous arboreal-shrub vegetation and very well-developed wet reed vegetation.

Figure 62. Example of a natural shorezone with good functionality that is classified as SFI category 2

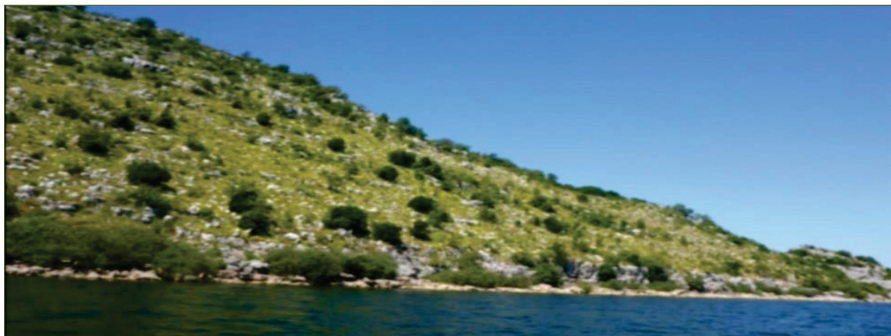
In all, 40 stretches, or 24.3% of the lake's Montenegrin shorezone (50.8 km), is classified as SFI category 3 (moderate). The stretches that fall into this category are usually found in the south-western part of the lake in HGM area III. Even though fully natural, the majority of the shoreline in this part of the lake has a lower level of functionality because the riparian vegetation has a limited width. It is generally formed by a very narrow band of shrubs and small trees (mostly chaste trees), separated with small areas of bare rock. For this reason, although there is a 'total absence of artificiality', these stretches' levels of functionality mean they can only attain SFI category 3. This is due to the steepness of the shore's topography and the nature of the substrate that prevents functional riparian vegetation growing in wider belts upland.

Figure 63. Example of a natural shore zone with lower functionality that is classified as SFI category 3

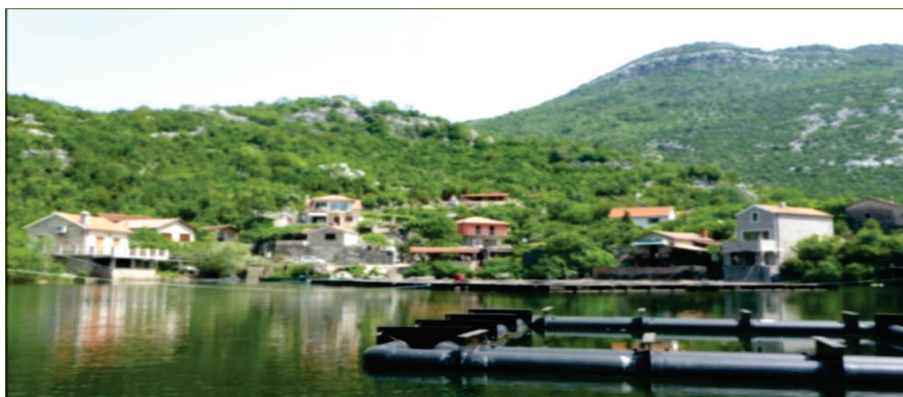
No stretches of the lake's Montenegrin shoreline were classified as SFI category 4 (poor). In all, 10 stretches, comprising 4.5% or 9.3 km of the total Montenegrin shoreline (208.8 km), do not have any functionality and are thus classified as SFI category 5 (bad). They are concentrated in areas experiencing strong anthropogenic impact, especially along the shorelines of the villages of Virpazar, Vranjina, Rijeka Crnojevića, Karuč and Dodoši, and in the north-western section of the lake, which belongs to HGM area II.

Figure 64. Example of an area experiencing strong anthropogenic impact and having poor functionality (SFI category 5)
