Concept for Phase B Rapid Catchment Rehabilitation Measures

1 Context

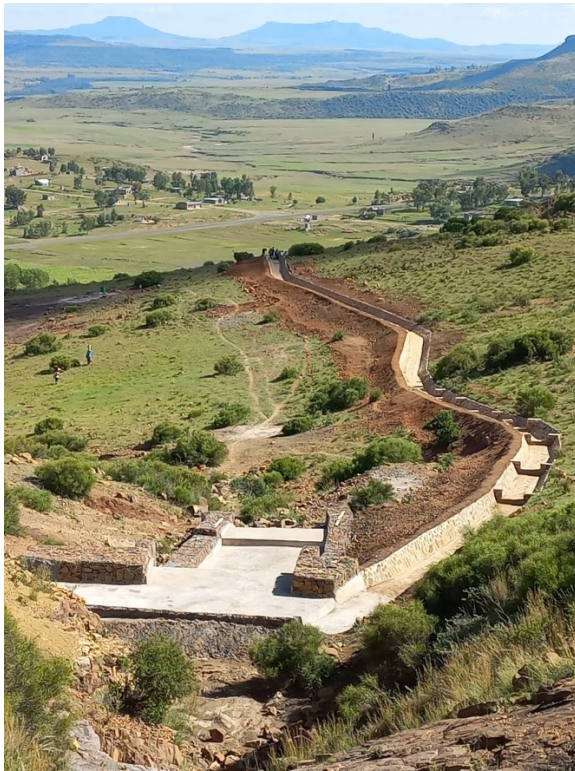
The whole area is water insecure. Near the village of Ha Mohlalefi is an old quarry that had been used as a borrow pit for road construction. In Phase A, a gabion weir and a stone masonry canal were constructed to divert water from a stream into a quarry to provide non-potable water for livestock, washing, etc.

Diversion weir and canal

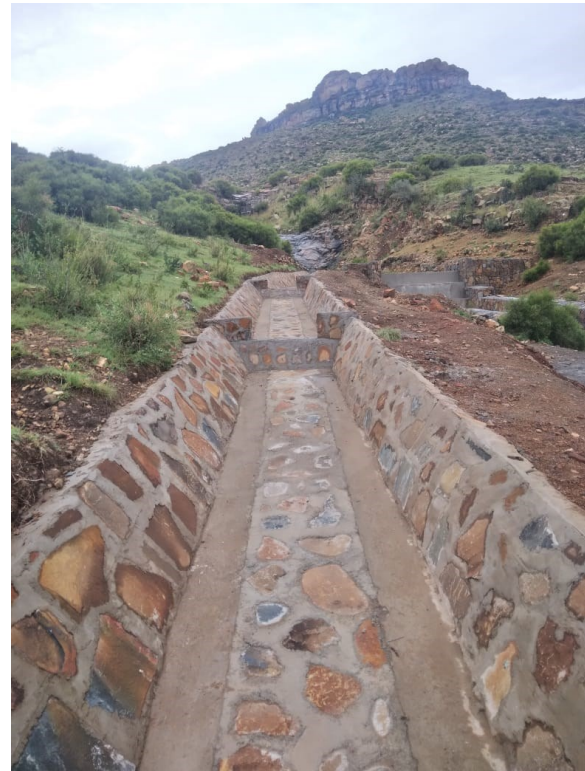
Diversion canal

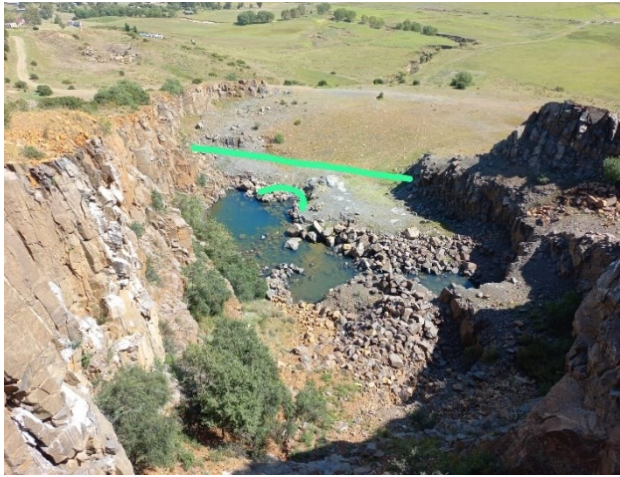
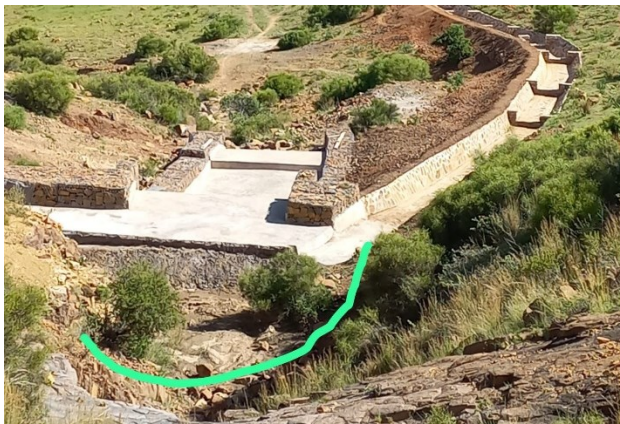
Figure 3-2 : Ha Mohlalefi Intervention Areas

The objectives of the Phase B measures are to provide safety measures (fencing, safe water abstraction point, water quality testing) around the small diversion weir, and along the quarry perimeter. In addition, erosion control and stormwater management measures are needed in the small catchment upstream of the diversion weir.

Quarry fencing and access

Weir fencing

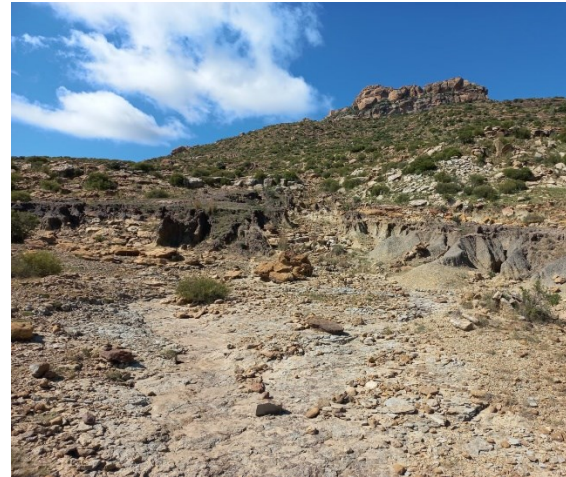
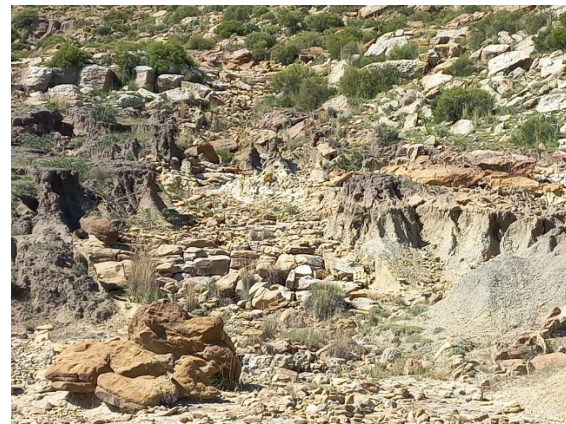
Area for stone bunds / check dams

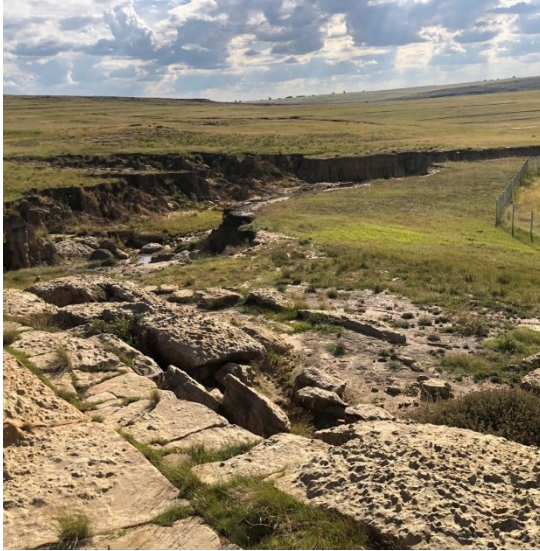
Gulley erosion

Figure 4-1 : Ha Ramarothole Intervention Areas

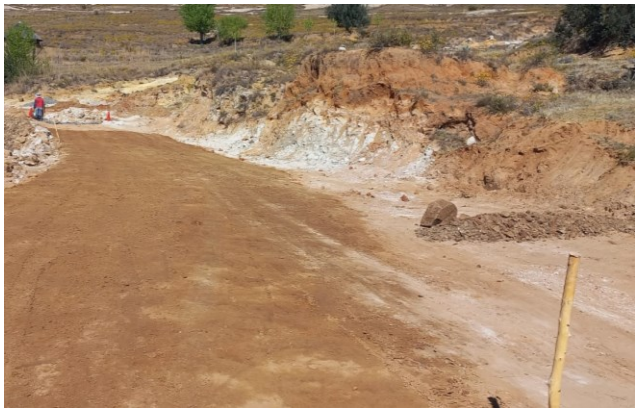
Road reshaping and stormwater management

Figure 5-1 : Phase A rehabilitation measures at Ha Khabo

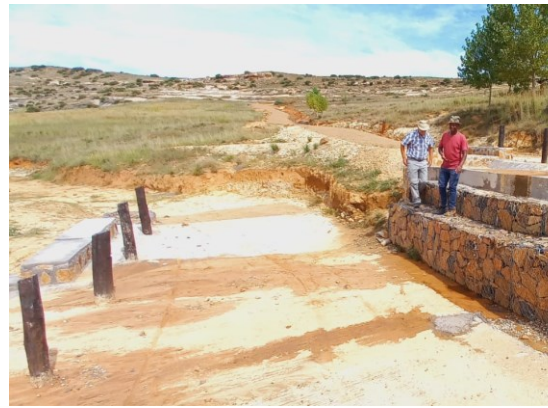
Drifts and stormwater disposal

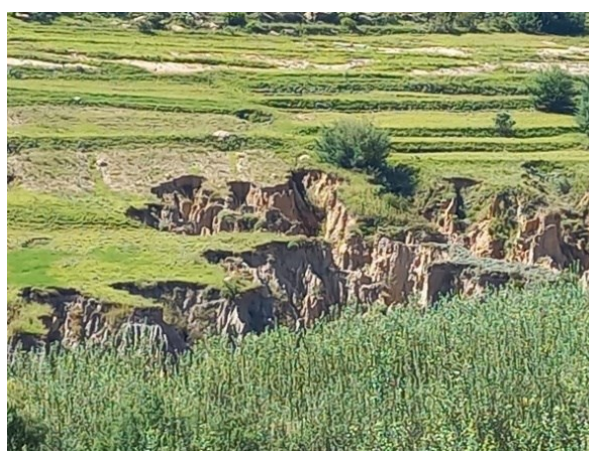
Gully arms cutting into cultivated fields

In Phase B, work will move further downstream / downslope. Heads of major gully arms that are cutting into cultivated land will be stabilised. Improved groundwater baseflow in the upper watershed will be utilised by protection of three springs, collection of the water with a pipe network and storage in water tanks.

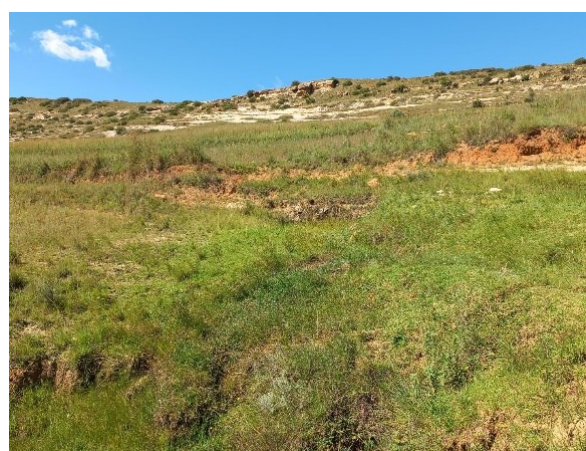
Spring downslope of rehabilitated upper watershed

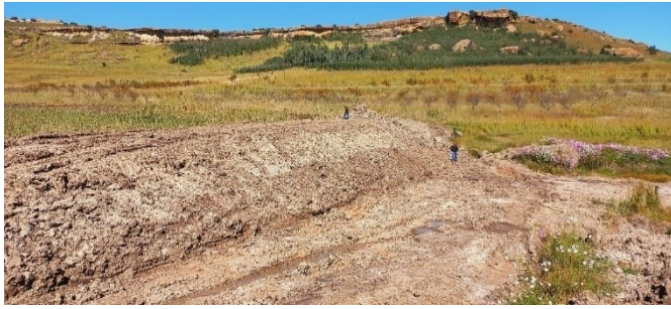
In Phase A, the dam wall was raised, and the spillway enlarged for dam safety purposes. The dam has raised water levels in the upstream wetland and has controlled erosion downstream where a gully below has stabilized. Erosion on the upper slopes of the watershed was protected and stabilised with construction of stone check dams.

Raising of the small earth dam

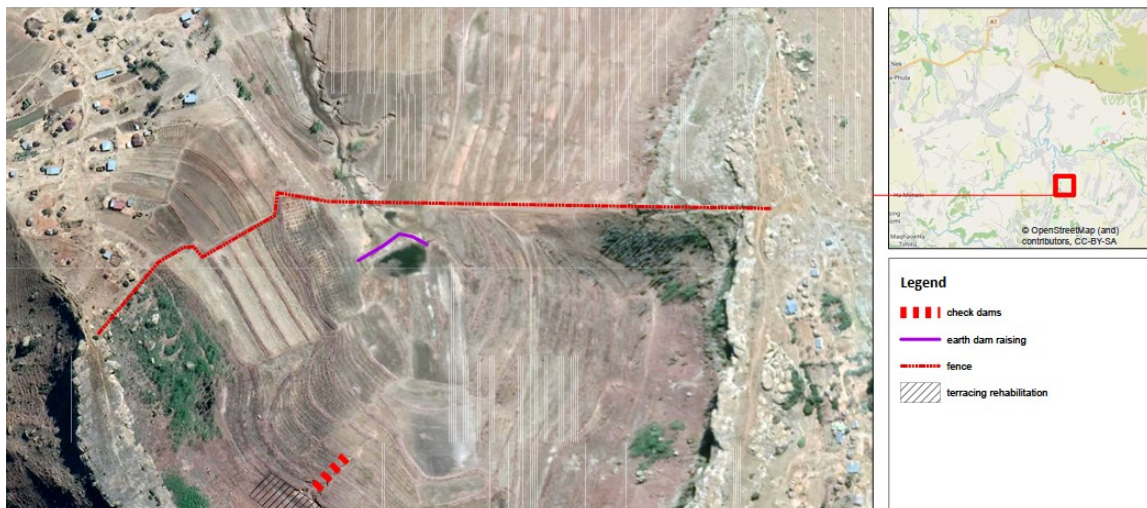
Figure 6-2 : Phase A measures south of the village of Ha Khabo

In Phase B, improved water yield from the raised earth dam will be used to re-establish the small-scale irrigation scheme. The existing CWT and certified community service providers (marketing agents) will establish a small farmer's co-operative (pre-condition) to operate and maintain the irrigation scheme.

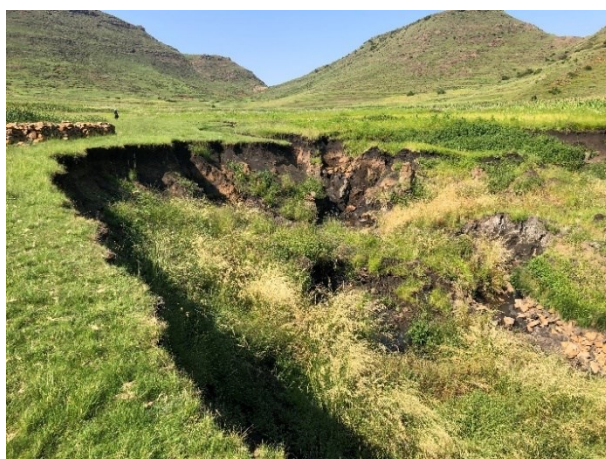
Gully head upstream of Puete

Figure 7-1 : Gully head and erosion along the Puete Wetlands/Stream

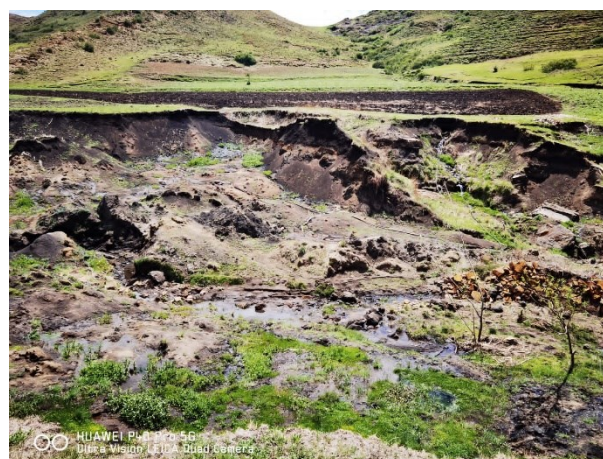
Gully head along the stream of Puete

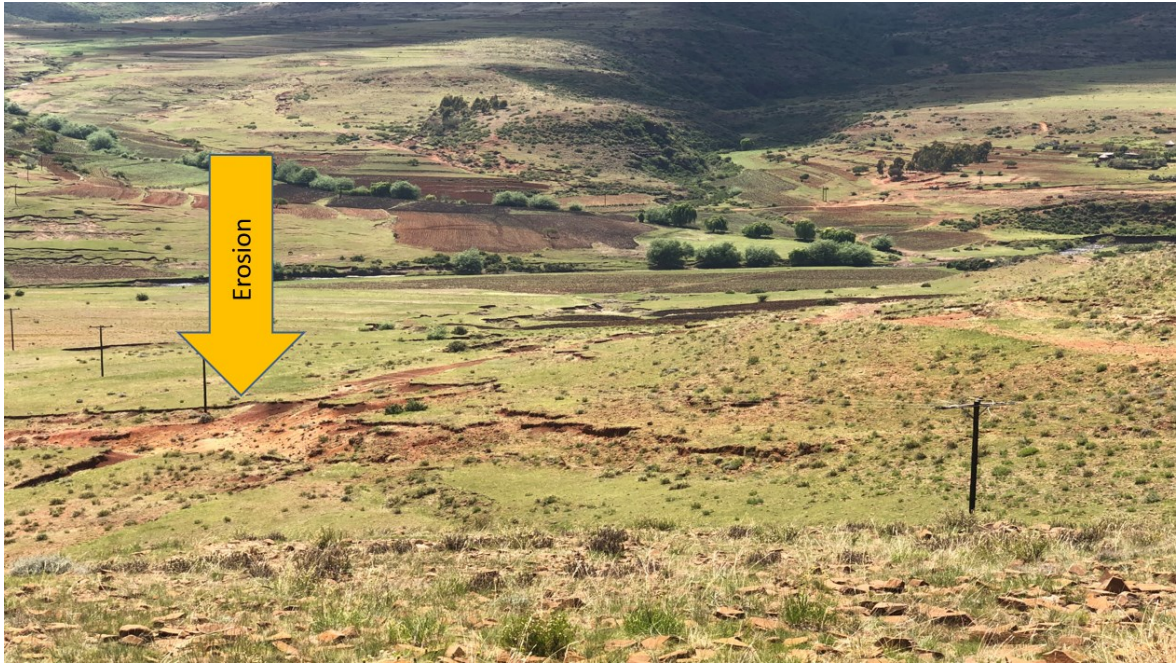
Figure 8-2 : Examples of eroion in the micro-catchment

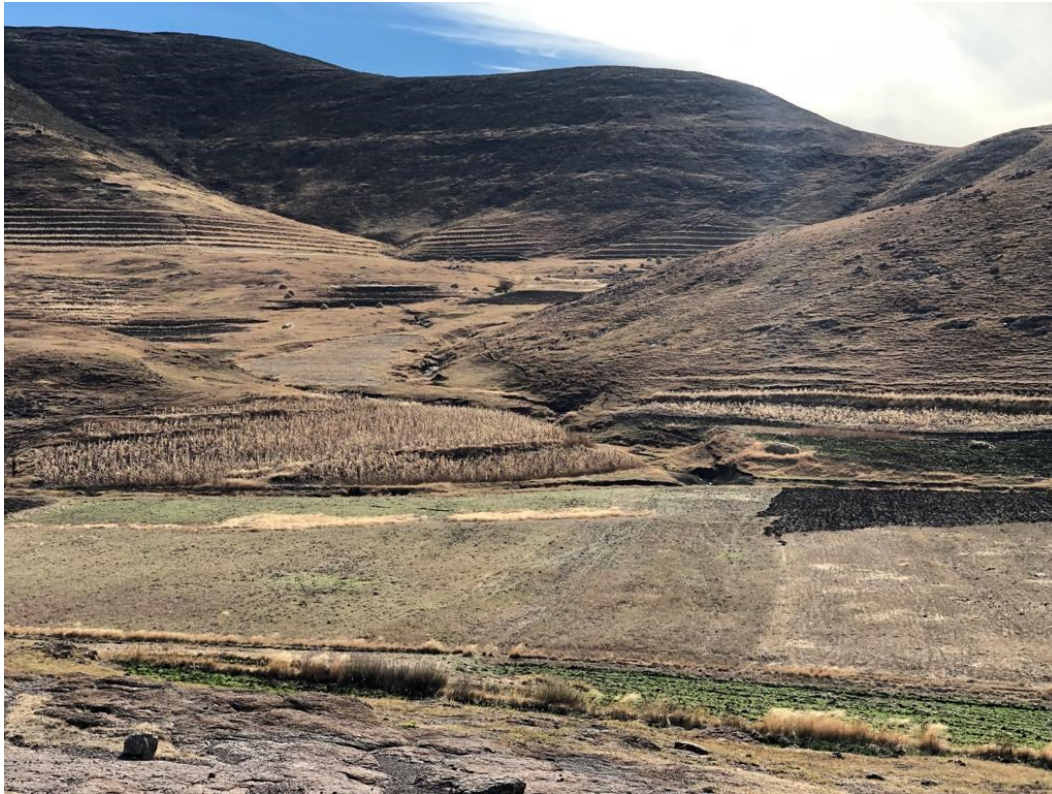
Figure 9-2 : Valley which has been considered as a water source (springs) for Ha Phallang

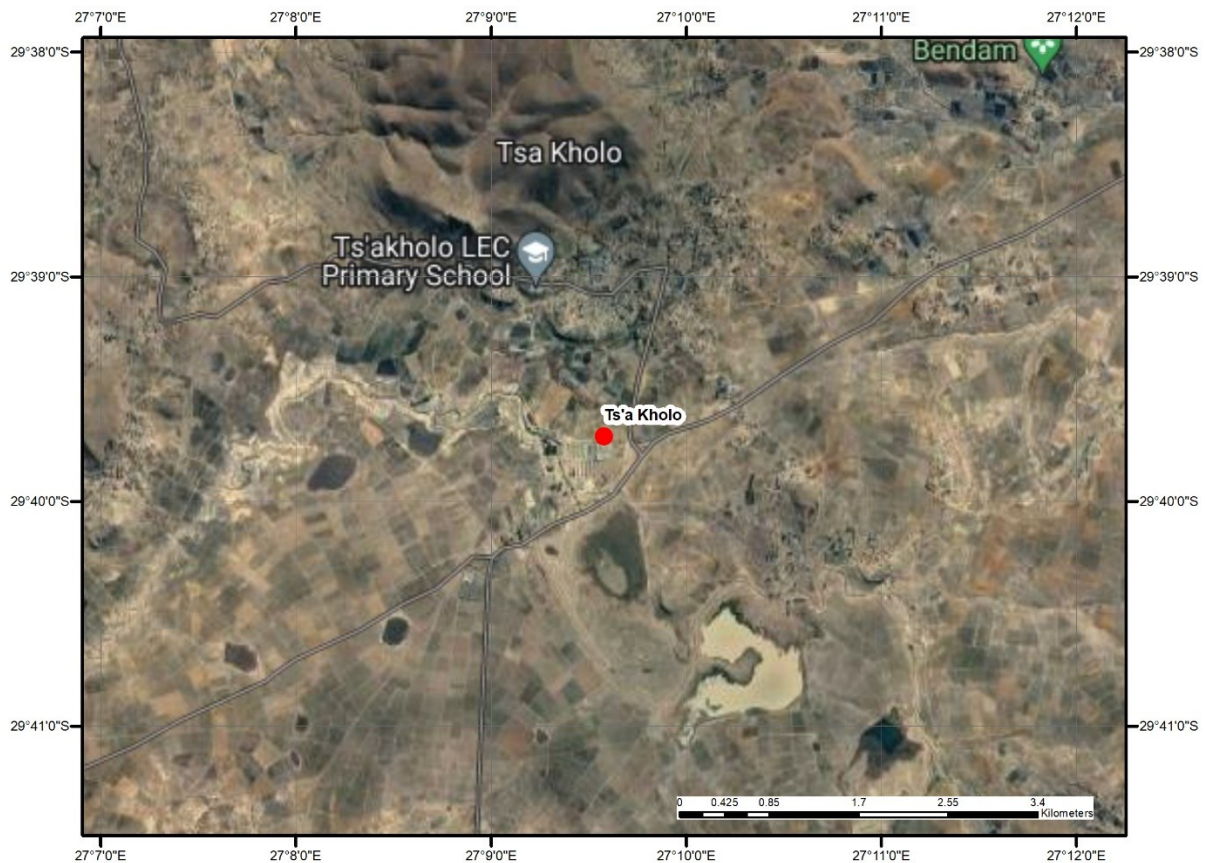
Figure 10-1 : Downstream part of Ts'a Kholo subcatchment near Bophelo Bioscience (Ts'a Kholo Dam at the bottom of the image)
