# PROJECT 3: HEADWATERS AND PROTECTED AREAS – SOMPOI, TADUANG AND UN RESERVOIRS, THAILAND

## 1. Project Overview

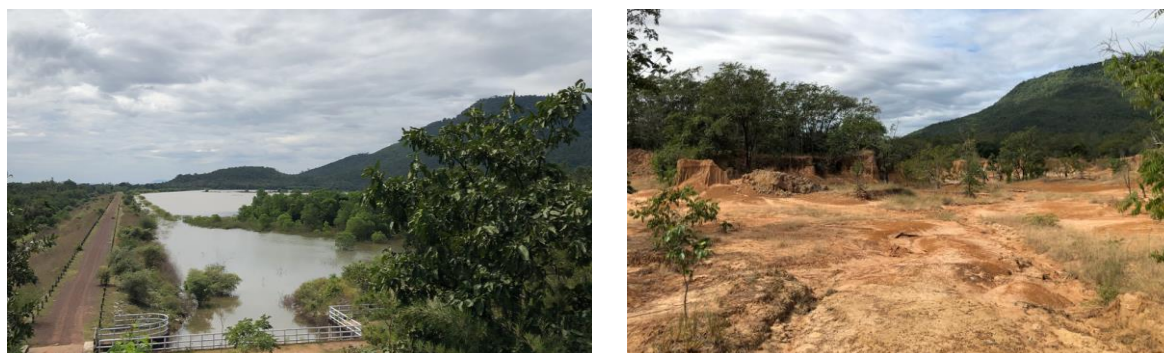
**Figure 1: Landscape upstream of reservoirs on the southern border of Tapraya national park**

The striking feature of this area is dispersive soil, which is sandy in nature and thus highly erodible. Rain can easily infiltrate and mobilise the loose sand particles. This causes high sediment loads in all rivers in the catchment. Erosion and thus sedimentation is strongest where vegetation has become sparse or entirely removed which is often the case along river-banks and in the buffer to the park following logging and temporary settlements. In addition, although satellite images suggest rather dense vegetation in the hills, the field mission found that the remaining trees and bushes do not have a dense canopy structure and erosion prone areas are common (Figure 1).

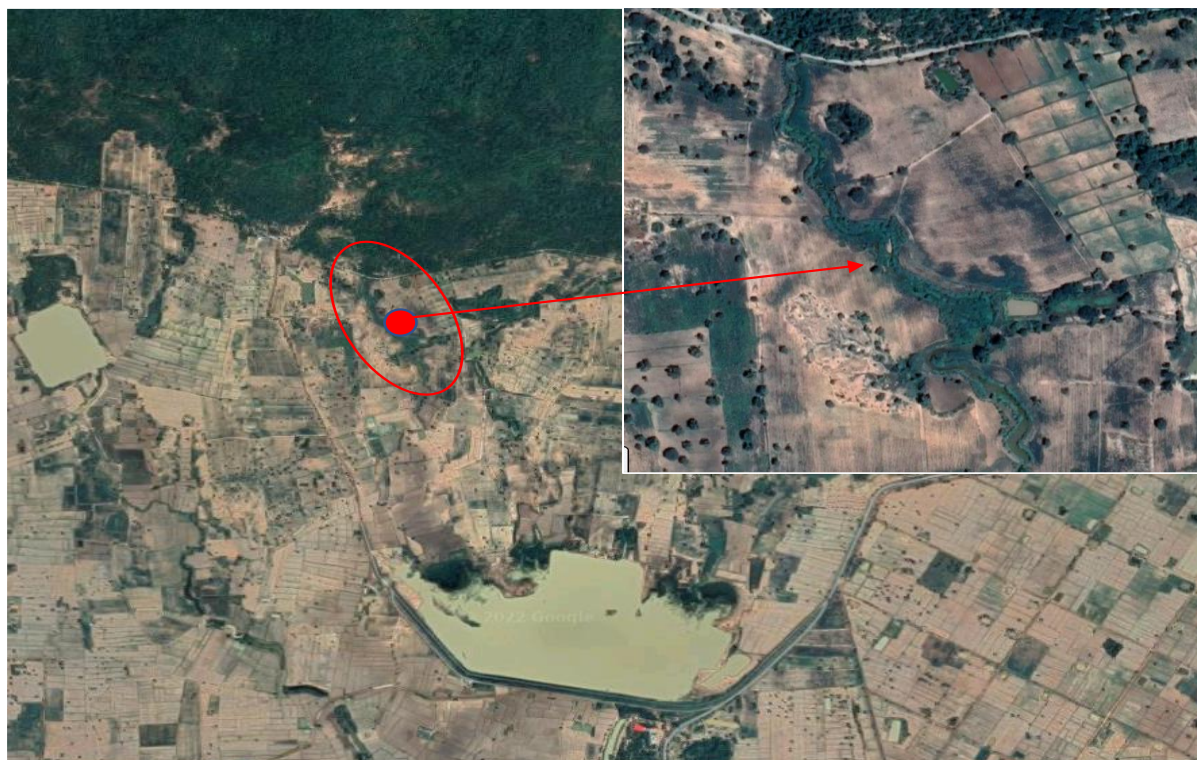
Figure 2: Example riparian buffer strip leading towards Sompoi Reservoir

Drainage channels were examined during the field mission to the Sompoi reservoir, including the riparian buffer presented in Figure 2. It was noted that the channel and associated buffer does not fully extend down to the Khlong Sompoi reservoir, due to encroachment at the edge of the channel from cassava plantations, and a road built over the waterway. The waterway is seasonal. During the wet season, water flows rapidly to the Sompoi reservoir due to the steep slopes of the channel.

A number of waterways and drainage corridors have been identified as having the opportunities for riparian buffer establishment and rehabilitation. For example, the natural drainage channel identified in Figure 2 has the potential to be restored to prevent erosion/sediment build up and facilitate its reconnection to the Sompoi Reservoir. The waterway is situated on public land, separated from adjacent private land through its buffer zone. The dimension of this u-shaped waterway was measured as 4m deep, with a top width of 19m and a base width of 16m but showing clear signs of sediment accumulation.

At the location identified in Figure 2, local government representatives suggested the provision of 2-3 leaky check dams along a stream to reduce flow and sediment transport during the wet and facilitate the storage of water for use by farmers during the dry season. Although situated on public land, such NbS measures would require engagement and permission from the Thap Thai SAO, with further consultation with local farmers who are active in the area.

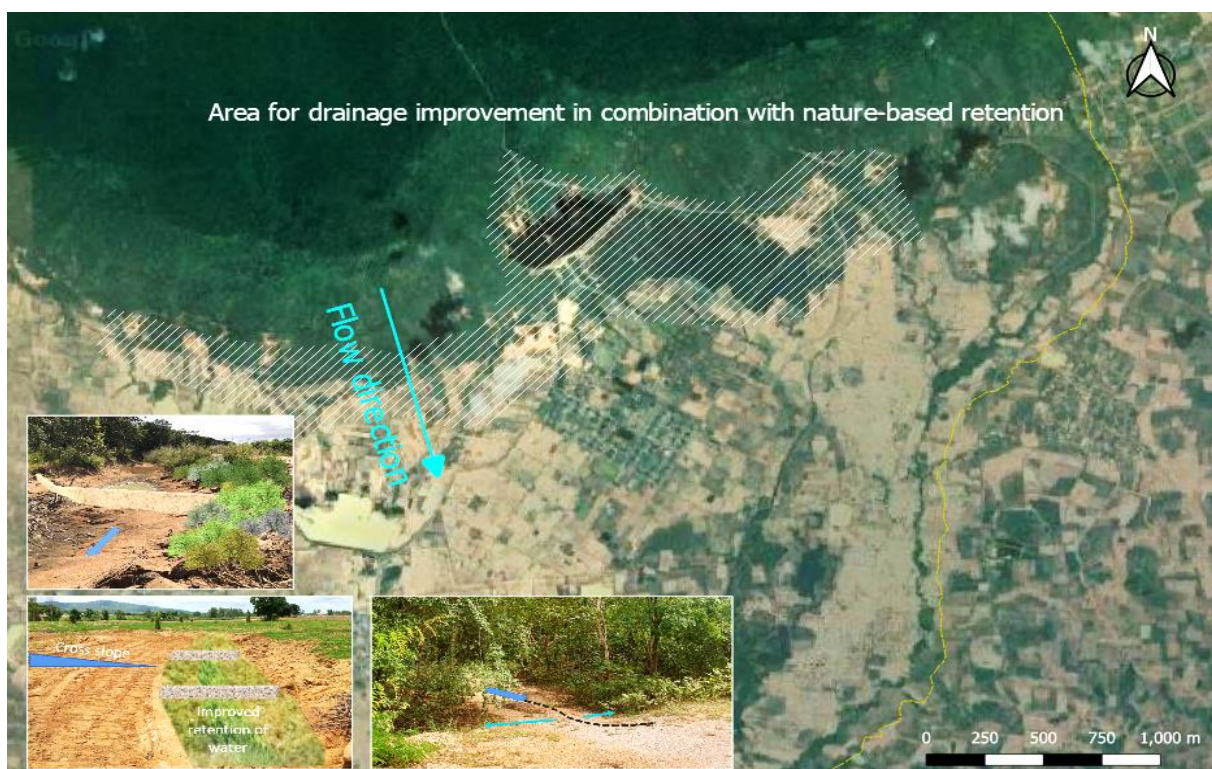
**Figure 3: Zone for lateral drainage structures**

The NbS and hybrid measures here are proposed for the transition zone from the hillside down to the plain where drainage improvement with nature-based retention would best demonstrate its potential. During the site visit to the Sompoi Reservoir, existing drainage channels were identified passing under the road and five drainage pipes along the road. Each pipe collects water from the streams to the north in the national park, transferring the flow to the agricultural land downstream and ultimately to the Sompoi Reservoir (Further details are provided in Annex 3, field report).

During the field visit, opportunities were identified for establishing a sediment trap at the entrance of pipe drain on the National Park side of the road (Figure 3). It was noted that any proposed NbS measures at this location would require engagement and permission from the National Park. In addition, along drainage channels feeding into the reservoirs (see Figure 2 and Figure 4 as example), 2-3 sediment traps could be established.

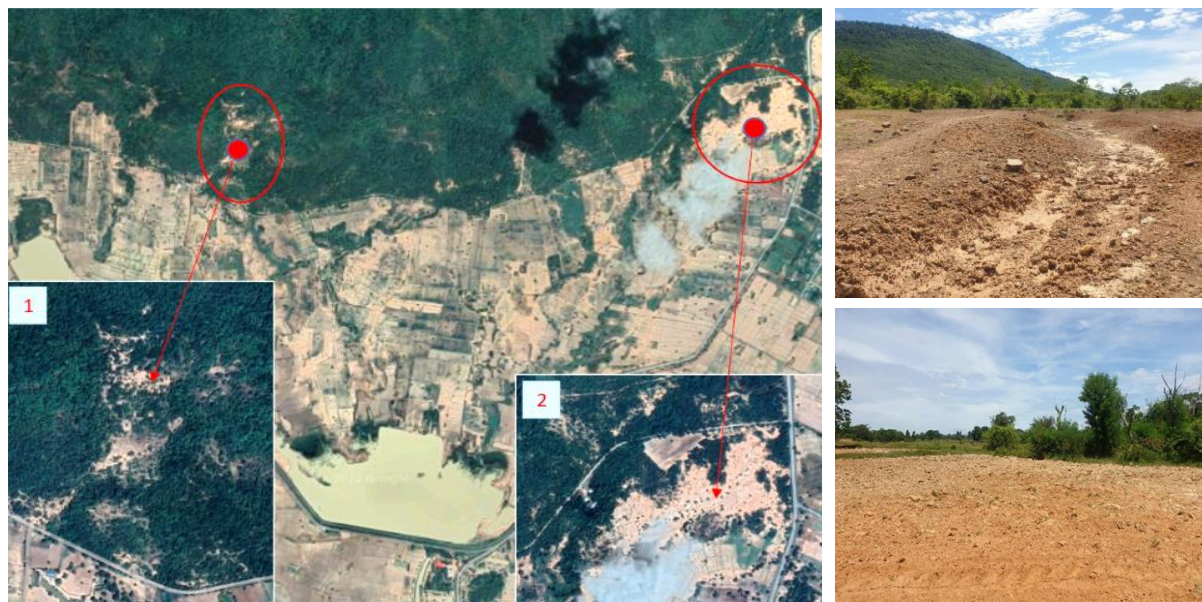
Figure 5: Identified degraded forest sites

Forest restoration at five seriously degraded locations identified within the Tapraya national park and its buffer, will require a distinctive combination of actions for the park, the buffer and the riparian corridors, because each have differing challenges and opportunities (Figure 5). Yet measures in each location share the same objectives, as identified in Measure 6 (Annex 1). Restoration demonstrations would target degraded areas within the NP.

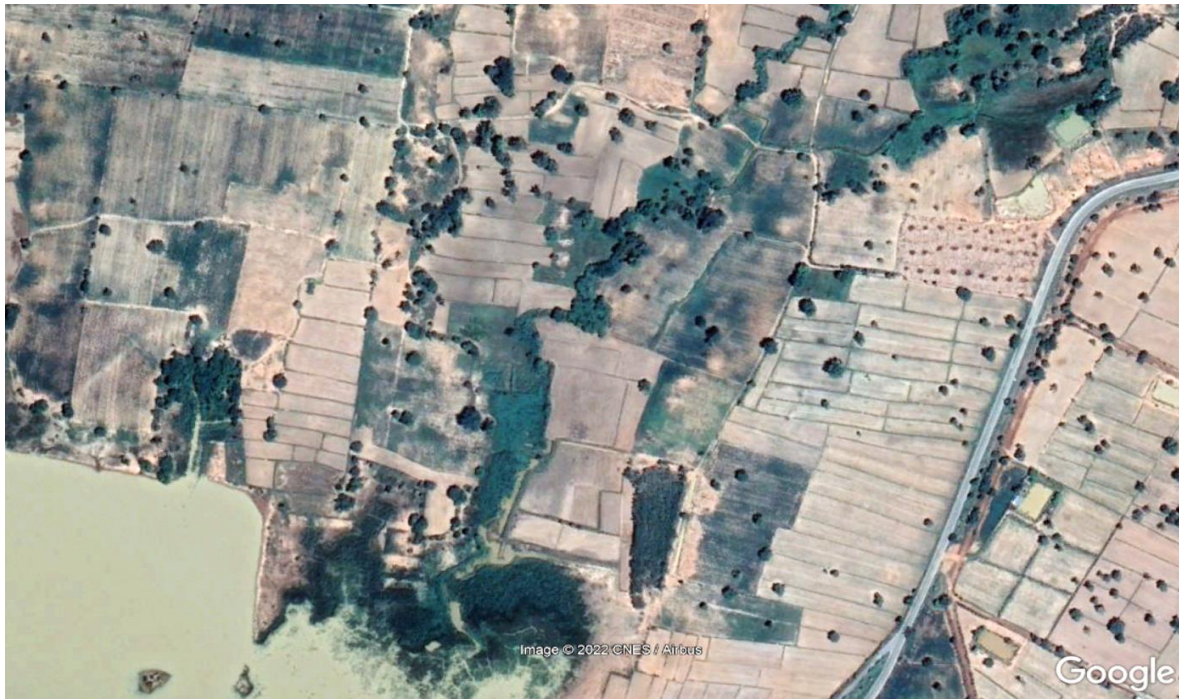
Figure 6: Agricultural landscapes for sustainable irrigation measures

Due to the sedimentation of the reservoir, drought risk and intensive agricultural practices within the catchment, water conservation irrigation measures are proposed for the three reservoirs in this landscape (see Annex 1, Measure 13). Field trenches and small-scale bioretention ponds provide opportunities for improved water resource management by farmers. Field trenches involve extensive ploughing to the right angle of a field's slope, filtering runoff water, reducing soil degradation and enhancing infiltration of surface run-off and soil moisture. These should be supported by the establishment of agricultural field buffers (see Annex 1, Measure 15). Figure 6 outlines potential demonstration locations for such interventions to the east of Sompoi.
